Supplementary file

Plasma-free dry etching of (001) β -Ga₂O₃ substrates by HCl gas

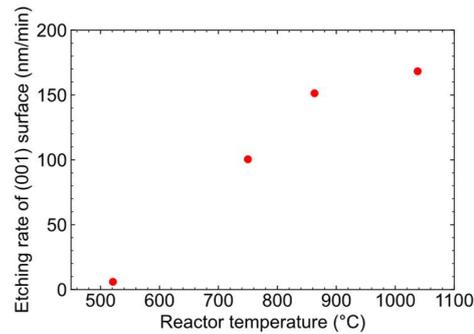
FIG. S1. Etching rate of (001) surface as a function of reactor temperature.

We performed HCl gas etching for SiO₂-masked (001) substrates at different temperatures and measured the depths of the etched depressions formed in the square windows ($100 \times 100 \mu\text{m}^2$) using a stylus profiler to understand the effect of temperature on the etching rate for the (001) surface. Figure S1 shows the obtained etching rate as a function of the reactor temperature. The etching rate monotonically increased with the reactor temperature. In the study, we focused on the substrate etched with the highest rate of ~ 170 nm/min at 1038°C and discussed the etched structures.

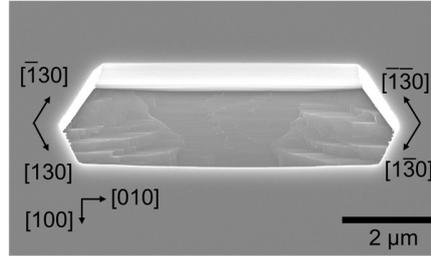
FIG. S2. Top-view scanning electron microscopy images of the etched trench formed under the dot pattern, corresponding to Fig. 1(a) and 1(b). Note that the pattern was not exactly the same one of the Fig. 1(a) and 1(b).

For better understanding the etched structures, particularly, sidewall morphologies, we removed the SiO₂ mask using buffered hydrofluoric acid and performed SEM observation again (Figures S2–S5).

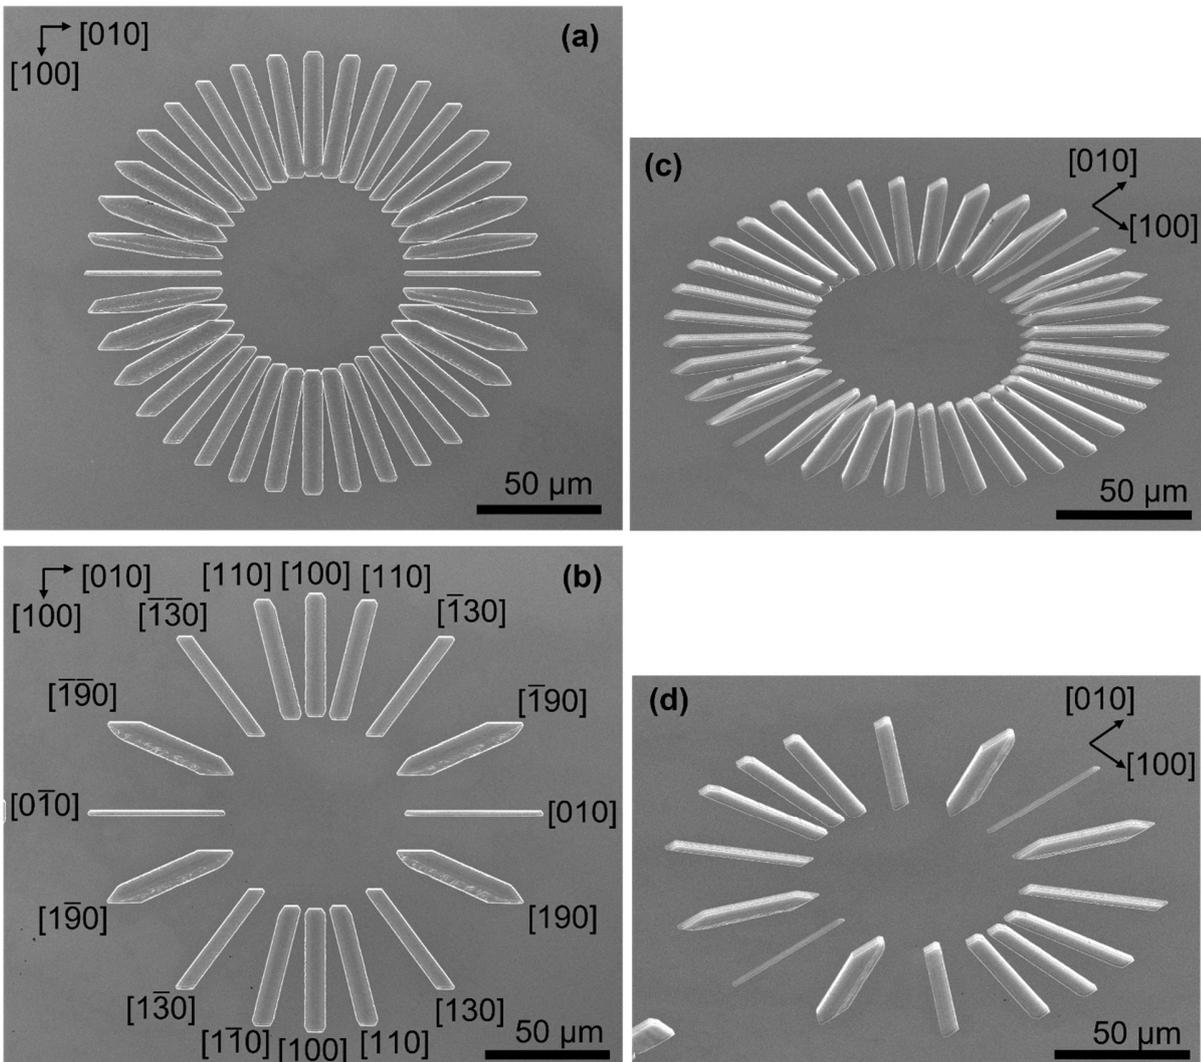
FIG. S3. (a) and (b) Top-view scanning electron microscopy images of the etched trenches on the radial-line-patterns, corresponding to Figs. 2 (a) and 2(b), respectively. (c) and (d) are tilted view (50° from the surface normal) of (a) and (b), respectively.

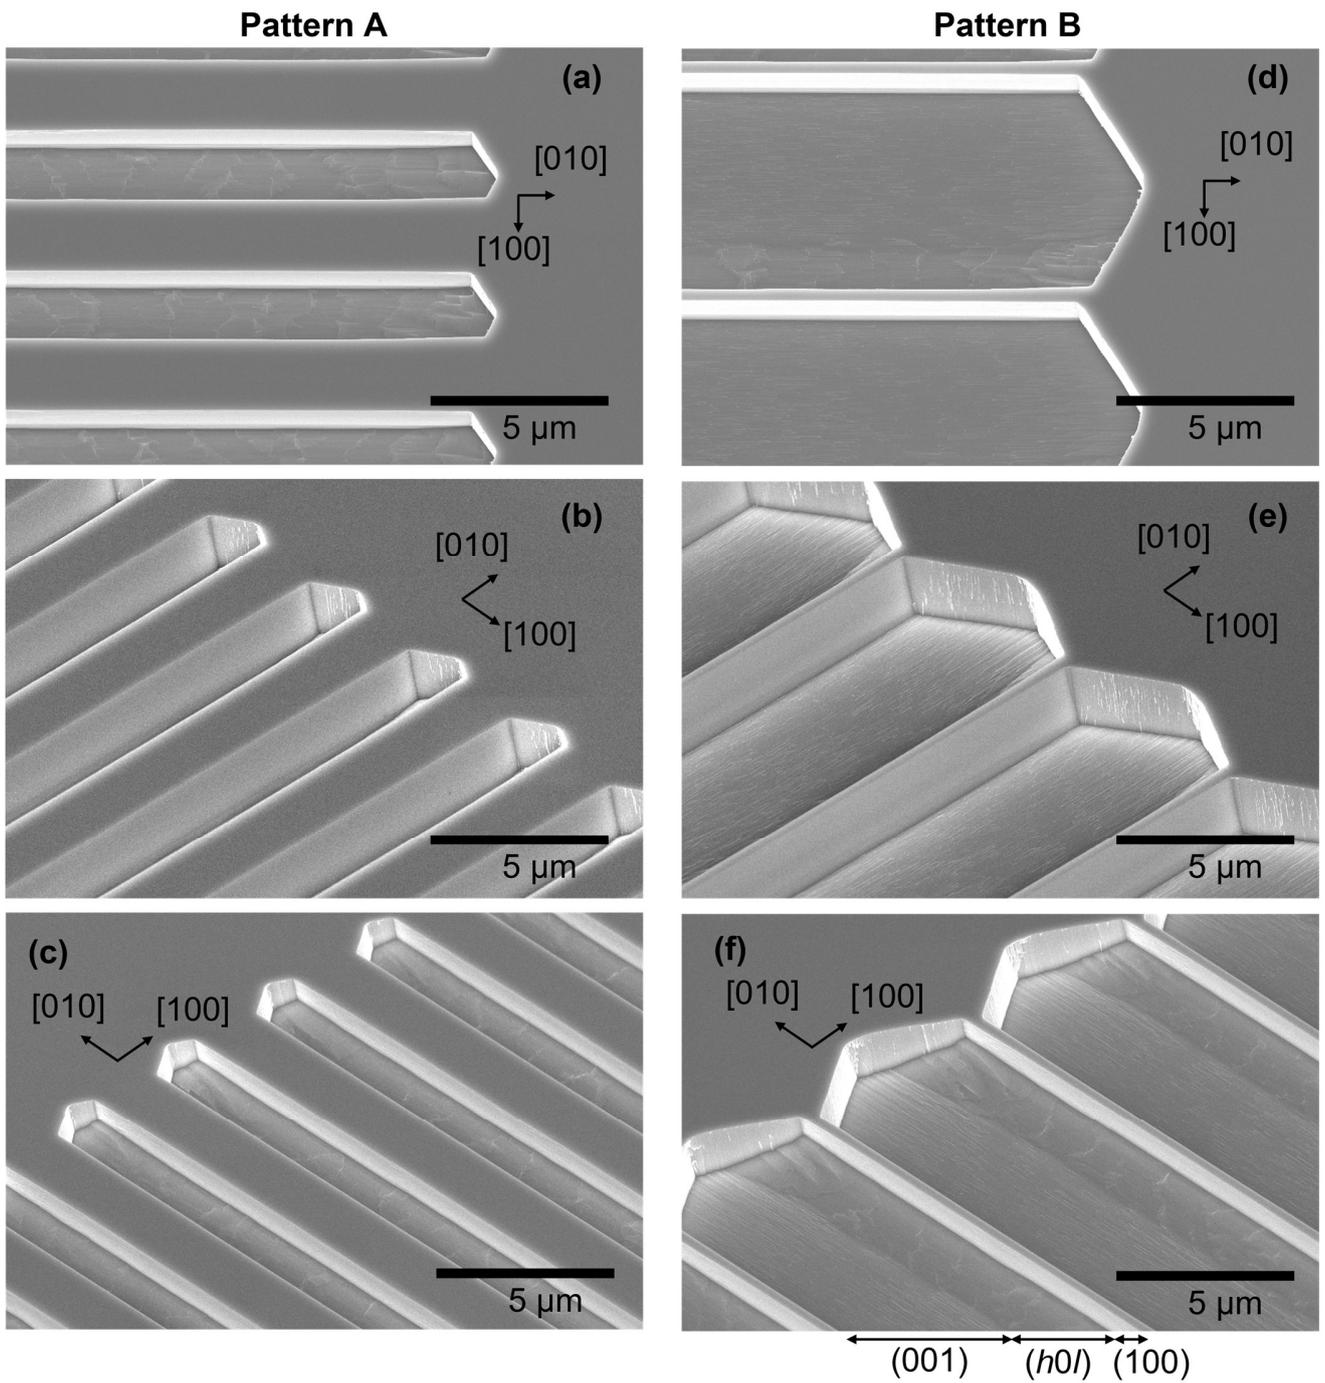
FIG. S4. Top- and tilted-view of scanning electron microscopy images (0° and 50° from the surface normal, respectively) of etched trenches produced using the $[010]$ -oriented stripe masks of (a)–(c) pattern A and (d)–(f) pattern B, corresponding to Figs. 3(a)–3(c) and 3(d)–3(f), respectively.

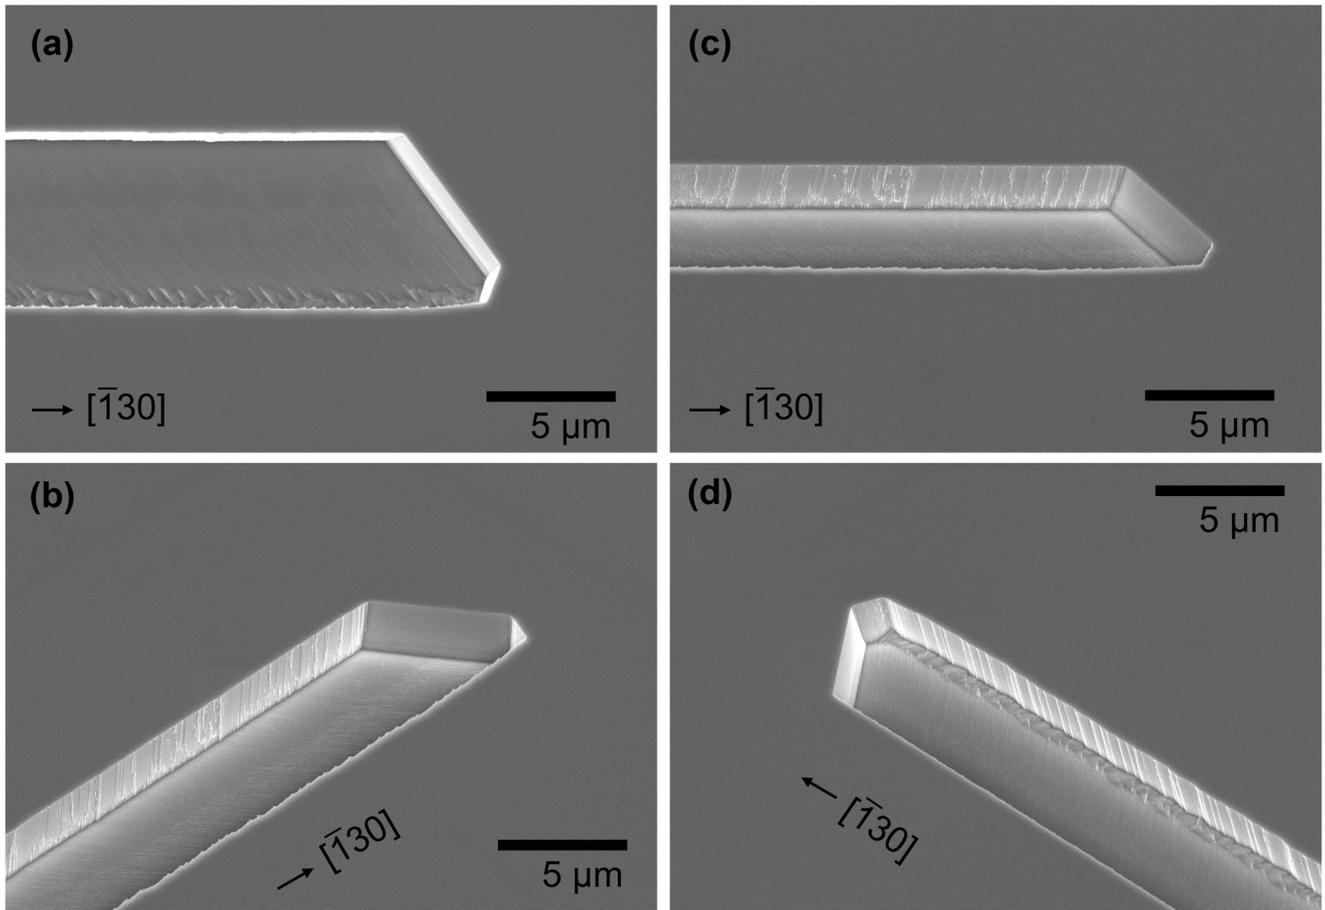
FIG. S5. Scanning electron microscopy images of a single etched trench along $[\bar{1}30]$, which is one of the radial lines in Figs. S3(b) and S3(d). (a) is top view and (b)–(d) are tilted view (50° from the surface normal) observed from the different in-plane directions. The sidewalls along $[\bar{1}30]$ were formed with (310) facets. The macro steps appeared on the (310) facet surfaces may be caused by the emergence of (100) facets.

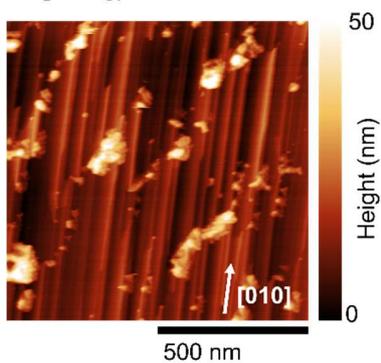
FIG. S6. Atomic force microscopy image of the (001) surface after HCl etching at 1038°C.

Surface morphology of the etched (001) surface was observed using atomic force microscopy (FIG. S6). See the text in the paper for the detail description of the morphology.
