Local crack arrestability and deformation microstructure evolution of hydrogen-related fracture in martensitic steel

Akinobu Shibata^{a,b,*}, Ivan Gutierrez-Urrutia^a, Akiko Nakamura^c, Taku Moronaga^c, Kazuho Okada^a, Yazid Madi^d, Jacques Besson^d, Toru Hara^a

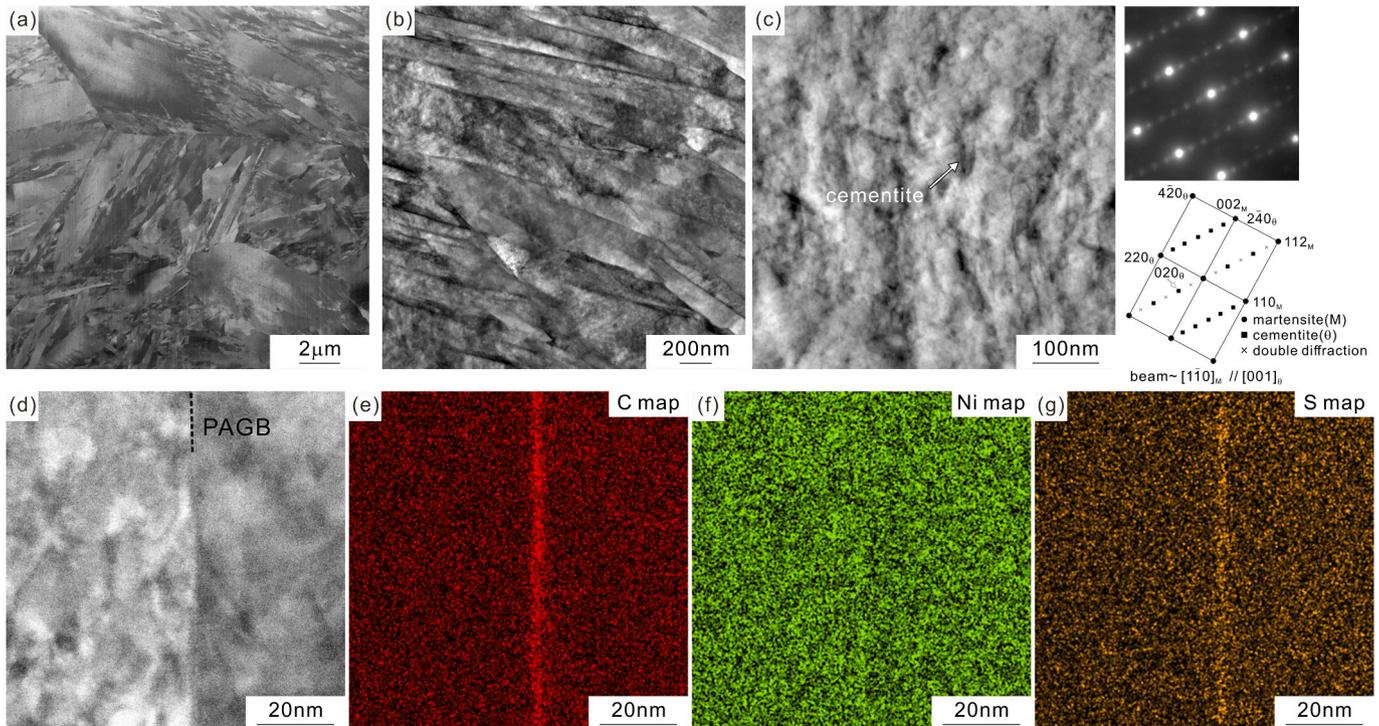
Fig. 1. (a) SEM image, (b – d) STEM images, and (e – g) STEM-EDX analysis results (the distribution maps of (e) carbon, (f) nickel, and (g) sulfur) of the heat-treated specimen. The corresponding electron diffraction pattern and key diagram are also shown in (c).

boundaries [55]. Although segregated carbon increases the boundary cohesive energy in steels [56], the occurrence of intergranular fracture even in the uncharged specimen shown in the following can be attributed to the sulfur segregated in the PAGBs.

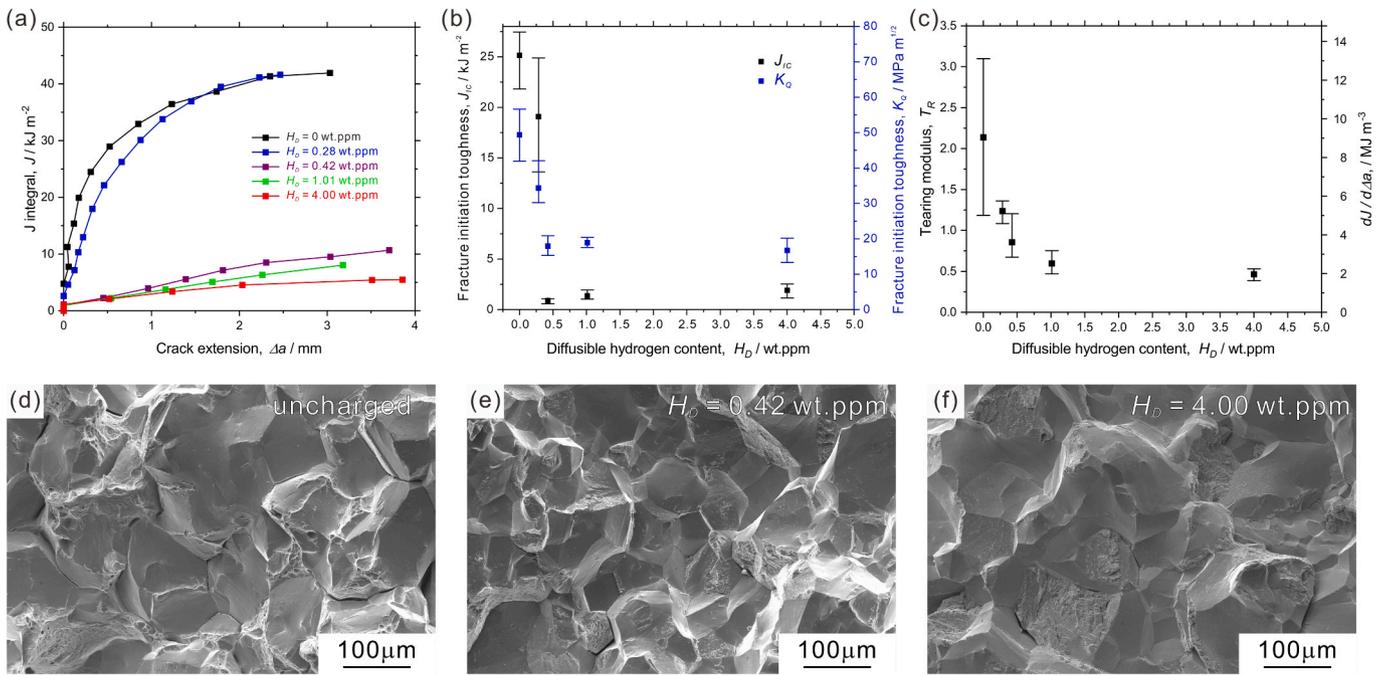
Fig. 2. (a) $J-\Delta a$ resistance curves, (b) fracture initiation toughness (J_{IC} (black) and K_{IQ} (blue)), and (c) tearing modulus with different H_D (the data from our previous paper [57] were reused). (d – f) SEM images of the fracture surfaces of the uncharged specimen (d), hydrogen-charged specimen with $H_D = 0.42$ wt ppm (e), and hydrogen-charged specimen with $H_D = 4.00$ wt ppm (f).

According to the previously reported uniaxial tensile test results [57], the 0.2% proof strength and tensile strength were 920 and 1191 MPa, respectively. Fig. 2(a – c) presents the $J - \Delta a$ resistance curves, fracture initiation toughness (J_{IC} and K_Q), and dimensionless tearing modulus (T_R) with different H_D obtained from the unloading compliance tests (the data from our previous study [57] was reused). All specimens satisfied the specimen size criteria for obtaining a valid plane-strain J_{IC} according to ASTM E1820–17 [52]. However, the requirements for a valid K_{IC} (ASTM E399–09 [58]) were not satisfied; therefore K_Q is an apparent fracture toughness. The resulting fracture surfaces in the uncharged and hydrogen-charged specimens mainly consisted of intergranular surfaces. Fig. 2(d – f) presents representative SEM images of the fracture surfaces (the uncharged specimen and the hydrogen-charged specimens with $H_D = 0.42$ and 4.00 wt ppm). The fracture initiation toughness (both J_{IC} and K_Q) decreased significantly with increasing H_D up to 0.5 wt ppm. However, the fracture initiation toughness remained unchanged with a further increase in H_D . This indicates that the small amount of hydrogen at approximately $H_D = 0.5$ wt ppm was sufficient to meet the lower limit of resistance for the onset of crack propagation. Additionally, a positive value of tearing modulus (that is, a certain degree of crack-growth resistance) was confirmed for the hydrogen-related intergranular fracture, even when the H_D was as high as 4.00 wt ppm. This could be attributed to the intrinsic crack growth resistance at microscopic scale.

charged specimens, the low-angle PAGB segment with a relatively large size impedes crack propagation. Plastic accommodation and resultant crack tip blunting occur in the uncharged specimen (Fig. 14 (c)). The crack tip blunting increases the resistance to crack propagation, resulting in the arrest of the crack. The un-cracked ligaments are then fractured in a ductile manner at a later fracture process. For the hydrogen-charged specimen, even if the size of the low-angle PAGB segment is sufficiently large to prevent crack propagation, obvious crack tip blunting does not occur [47]. In many cases, the crack can continue propagating inside the PAG in a quasi-cleavage manner (Fig. 14 (d)). The propagation of the quasi-cleavage cracks is accompanied by the development of pronounced deformation microstructures (Fig. 12). In other words, cracks can propagate within the PAG even after the intergranular crack propagation has stopped. When the crack reaches another PAGB, it propagates again in an intergranular manner. On the contrary, when the arrested intergranular crack cannot propagate further within the grain as a quasi-cleavage crack, resulting in a notably large opening displacement in the wake region, plastic deformation large enough to form an ultrafine-grained structure occurs at the arrested crack tip (Figs. 6 and 14 (d)). Accordingly, we can propose that, due to the intense localized plastic work involved in the arrest of intergranular cracks (Fig. 6) and the propagation of quasi-cleavage cracks (Figs. 11 and 12), there exists a certain degree of resistance to crack propagation (intrinsic crack growth resistance), even in the case of high hydrogen concentrations (Fig. 2).

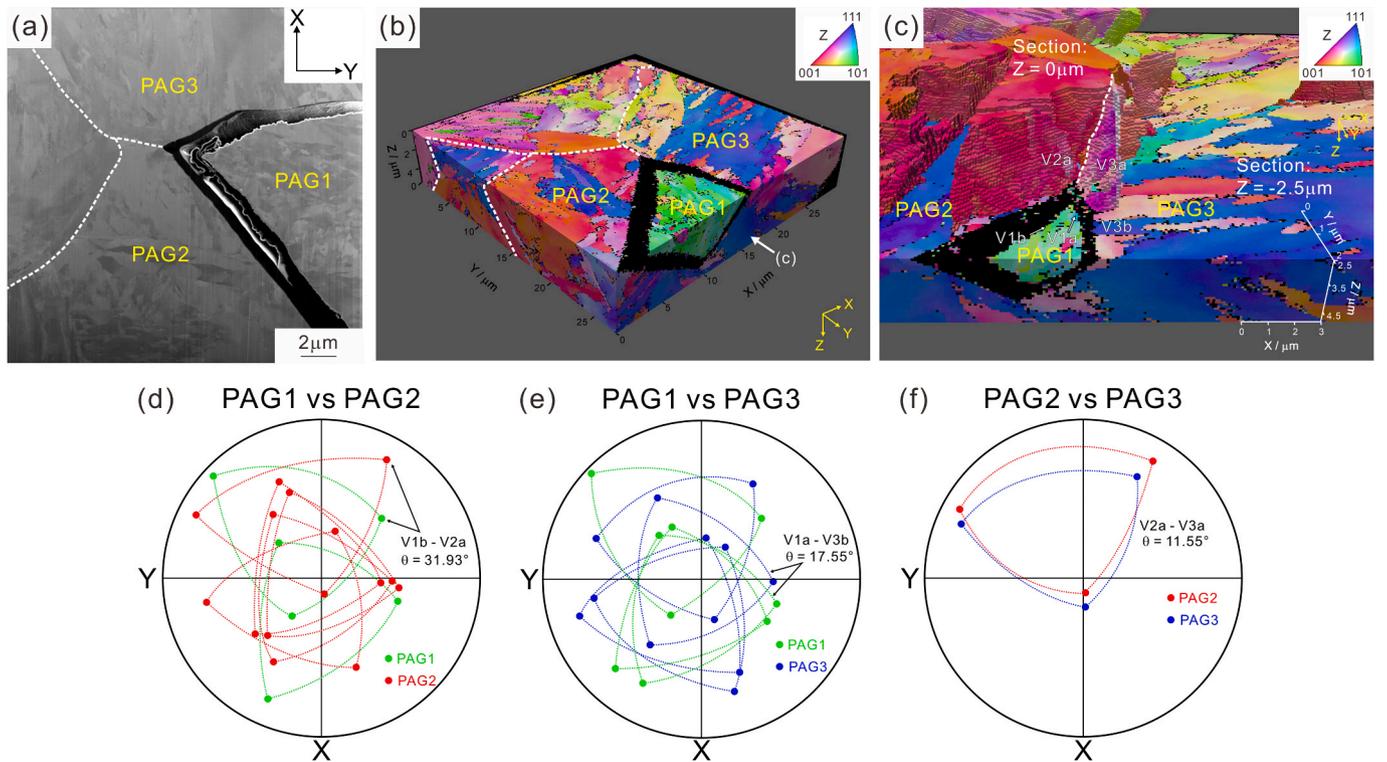
Fig. 3. (a) SEM image ($Z = 0 \mu\text{m}$), (b, c) 3D-EBSD orientation maps of the entire analyzed volume and at the top section $Z = -2.5 \mu\text{m}$, and (d – f) $\langle 001 \rangle$ pole figures showing the orientations of the martensite variants facing the prior austenite grain boundaries.

Fig. 3 depicts the microscopic crack propagation behavior in the uncharged specimen analyzed using 3D-EBSD; (a) a SEM image of the first section and (b, c) 3D-EBSD orientation maps (the observation direction of (c) is indicated in (b)). The positions of the PAGBs ahead of the crack are indicated by the white-dashed lines (in the following images,

the white-dashed lines indicate the positions of the PAGBs). The colors in the EBSD orientation maps represent the crystal orientation parallel to the Z direction according to the inserted stereographic triangle. The crack propagated at the boundaries between PAG1 and PAG2 and between PAG1 and PAG 3 but was arrested at the boundary between PAG2

and PAG3. Fig. 3(d – f) illustrates the $\langle 001 \rangle$ pole figures of the martensite variants facing the PAGBs. Several martensite variants are observed to be adjacent to the PAG1 / PAG2 and PAG1 / PAG3 boundaries, indicating that the length of each segment at these PAGBs is short (sub-micrometer size). Additionally, Fig. 3(d, e) indicates that the

minimum misorientation across the PAGBs is relatively large (31.93° between V1b and V2a at the PAG1 / PAG2 boundary and 17.55° between V1a and V3b at the PAG1 / PAG3 boundary). In contrast, as shown in Fig. 3(c, f), a large part of the PAG2 / PAG3 boundary (size of several micrometers) consists of a boundary segment between V2a and V3a, whose misorientation is 11.55° (the V2a and V3a regions above the observed section ($Z = -2.5 \mu\text{m}$) are displayed in Fig. 3(c)). Accordingly, the results demonstrated that a low-angle PAGB segment of several micrometers in size can act as an obstacle to intergranular crack propagation in the uncharged specimen.

In addition to the previous studies [30,47], the results shown in Figs. 3, 4 and 10 clearly demonstrate that the low-angle PAGB segments impeded intergranular crack propagation. Here, we discuss the effect of low-angle PAGB segments with a relatively small size on intergranular crack propagation (Fig. 14 (a, b)). For the uncharged specimen, the crack propagates under a large load, and the stress concentration area around the crack tip is large. Therefore, even when the crack reaches a

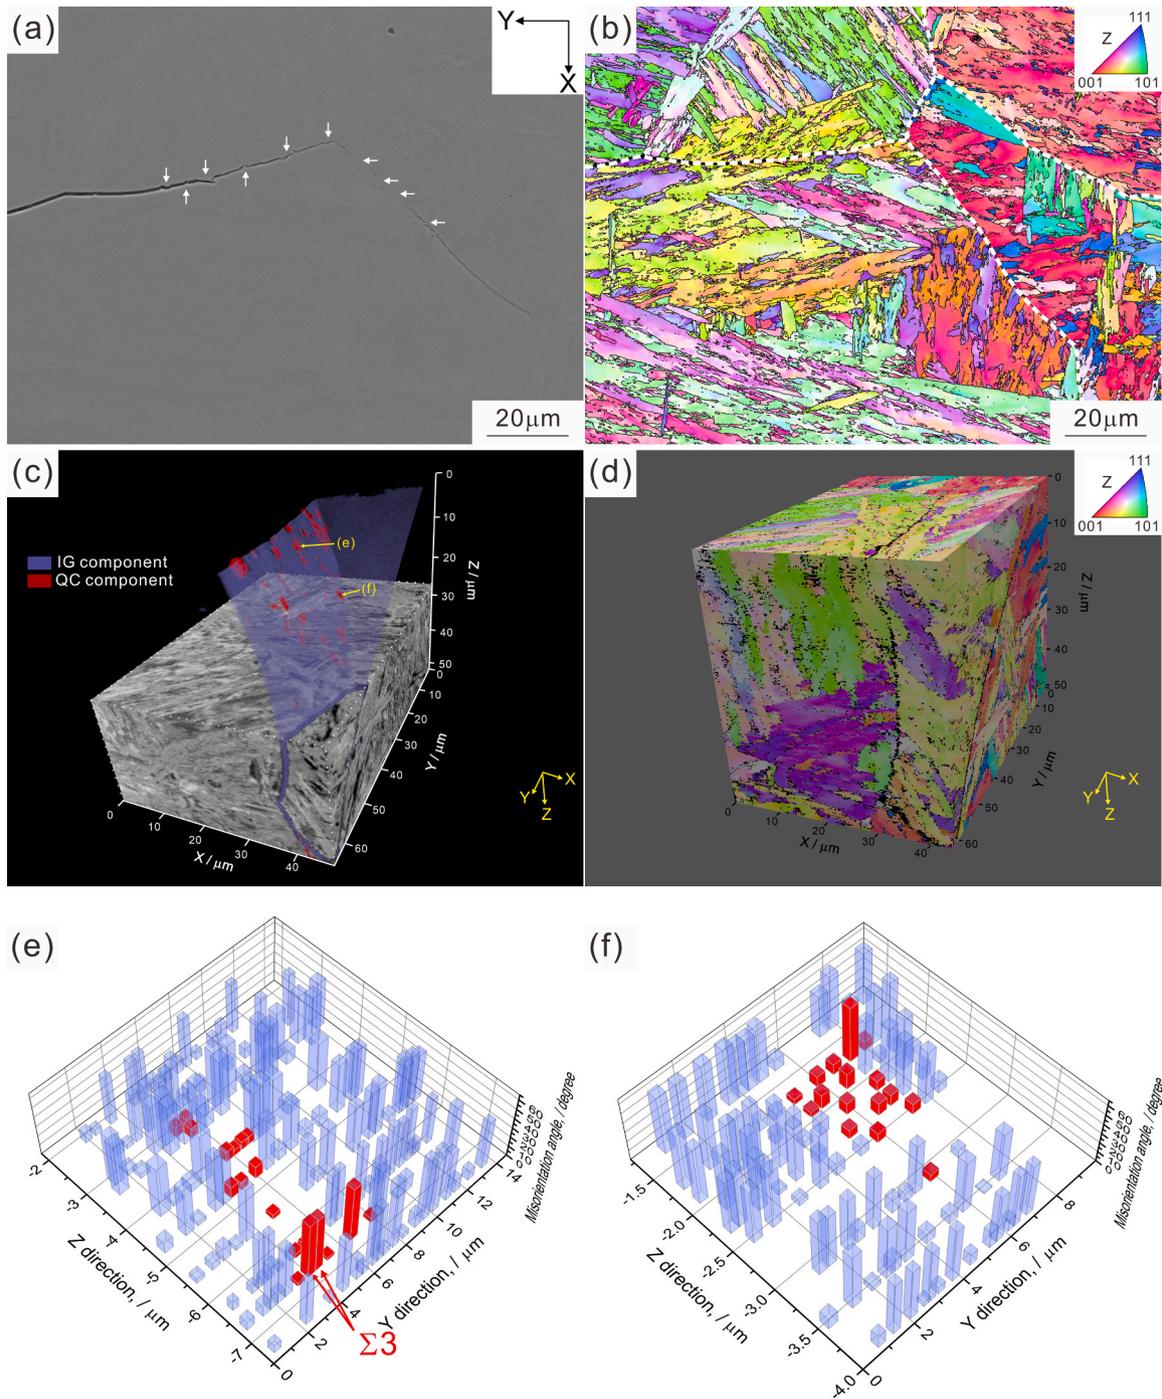
Fig. 4. (a, b) SEM image and EBSD orientation map ($Z = 0 \mu\text{m}$), (c) 3D crack morphology (blue: intergranular crack component and red: quasi-cleavage crack component), (d) 3D-EBSD orientation map, and (e, f) misorientation of the prior austenite grain boundary segments at the regions indicated in (c) of the hydrogen-charged specimen with $H_D = 0.42 \text{ wt ppm}$.

Fig. 4(a, b) shows a SEM image and the corresponding EBSD orientation map

orientation map of the first section of the hydrogen-charged specimen with $H_D = 0.42 \text{ wt ppm}$. Cracks propagated at the PAGBs. However, as indicated by the white arrows in Fig. 4(a), numerous very fine uncracked ligaments were formed, and the cracks frequently deviated from the PAGBs, leading to discontinuous crack propagation. The reconstructed 3D morphology of the crack and the corresponding 3D-EBSD orientation map are presented in Fig. 4(c, d), respectively. The frequent deviation of the crack from the PAGB plane can be confirmed in Fig. 4(c) (blue: intergranular crack component, red: quasi-cleavage crack component). Fig. 4(e, f) shows the misorientation profiles of the PAGB segments in the regions indicated in (c), and the misorientation

angle is represented by the height of the bar. The red bars correspond to the positions of the un-cracked ligament, that is, the positions where the intergranular crack was not continuous on the PAGB plane. Although some PAGB segments with large misorientation are involved, the un-cracked ligaments form at the PAGB segments with small misorientations or segments with $\Sigma 3$ relationship. Therefore, the results shown in Fig. 4 indicate that, in the case of hydrogen-related fractures, low-angle PAGB segments with small size can impede crack propagation.

As illustrated in Fig. 4, hydrogen-related intergranular fracture predominantly occurs at PAGBs, though there are several types of high-angle boundaries in lath martensite structure, including block boundaries and packet boundaries. Previously, hydrogen microprint analysis revealed that deformation enhanced accumulation of hydrogen around the PAGBs [72,73]. We can propose three potential explanations for preferential hydrogen accumulation leading to intergranular cracking at PAGBs; (i) segregation of impurities, (ii) coherency, and (iii) stress/strain concentration. (i) Because the boundaries in martensite other than PAGB are formed during quenching, we can expect that segregation of impurities at PAGB is significantly higher compared to the other boundaries. The segregated impurities at PAGBs could facilitate their interaction with hydrogen, leading to the preferential accumulation of hydrogen at PAGBs. (ii) The boundaries other than PAGB are basically variant boundaries with a definite crystallographic orientation relationship. In contrast, PAGB is a kind of random boundary. Consequently, the coherency of PAGB is lower, resulting in a larger amount of free volume. This lower coherency makes PAGBs prone to the accumulation of hydrogen. (iii) Although previous studies reported that the most effective boundary for strength in martensitic steel is block boundary [74,75], we can speculate that large stress/strain concentrations arise around PAGBs during deformation. The low crystallographic coherency of PAGB could also increase stress/strain accumulation due to low slip compatibility. As hydrogen tends to accumulate around high stress/strain regions [76–78], PAGBs become preferential trapping site of hydrogen.

low-angle PAGB segment with a small size, it has little effect on the crack propagation, resulting in continuous crack propagation (Fig. 14 (a)). For the hydrogen-charged specimen, even when the size of the low-angle PAGB segment is small, the segment can impede crack propagation owing to the small stress concentration range (Fig. 14 (b)). Furthermore, this behavior is also associated with the hydrogen accumulation behavior. Previously, hydrogen microprint analysis indicated that deformation promoted hydrogen accumulation around the PAGBs [72, 73]. Generally, the segregation of impurities at the grain boundary decreases as the grain boundary misorientation decreases [79]. Although the local hydrogen distribution is difficult to quantitatively evaluate (in particular, the distribution of diffusible hydrogen), it can be speculated that the local concentration of hydrogen around the low-angle PAGB segments is expected to be lower than that around the high-angle PAGB segments. The low hydrogen concentration could suppress the degradation of the cohesive energy of the PAGB segments. As described above, the reduction in the cohesive energy by hydrogen is more pronounced at the higher-energy grain boundaries [69]. Namely, the presence of hydrogen increases the difference in the cohesive energy between low-angle and high-angle PAGB segments. Therefore, the high-angle PAGB segments are preferentially cracked, while the low-angle PAGB segments still exhibit high resistance to cracking, leading to discontinuous crack propagation as shown in Fig. 4. This could elucidate why even low-angle PAGB segments with small size, specifically sub-micrometer size, can impede the propagation of hydrogen-related crack. As shown in Fig. 1, sulfur is segregated in the PAGB. If the main reason for the discontinuous crack propagation is sulfur segregation depending on grain boundary character, intergranular crack propagation behavior should be the same between the uncharged specimen and hydrogen-charged specimen. Because the obstacle effect of low-angle PAGB segments with a small size can be observed only in the hydrogen-charged specimen, it is reasonable to consider that the presence of hydrogen played a primary role on the crack propagation behavior depicted in Fig. 4.

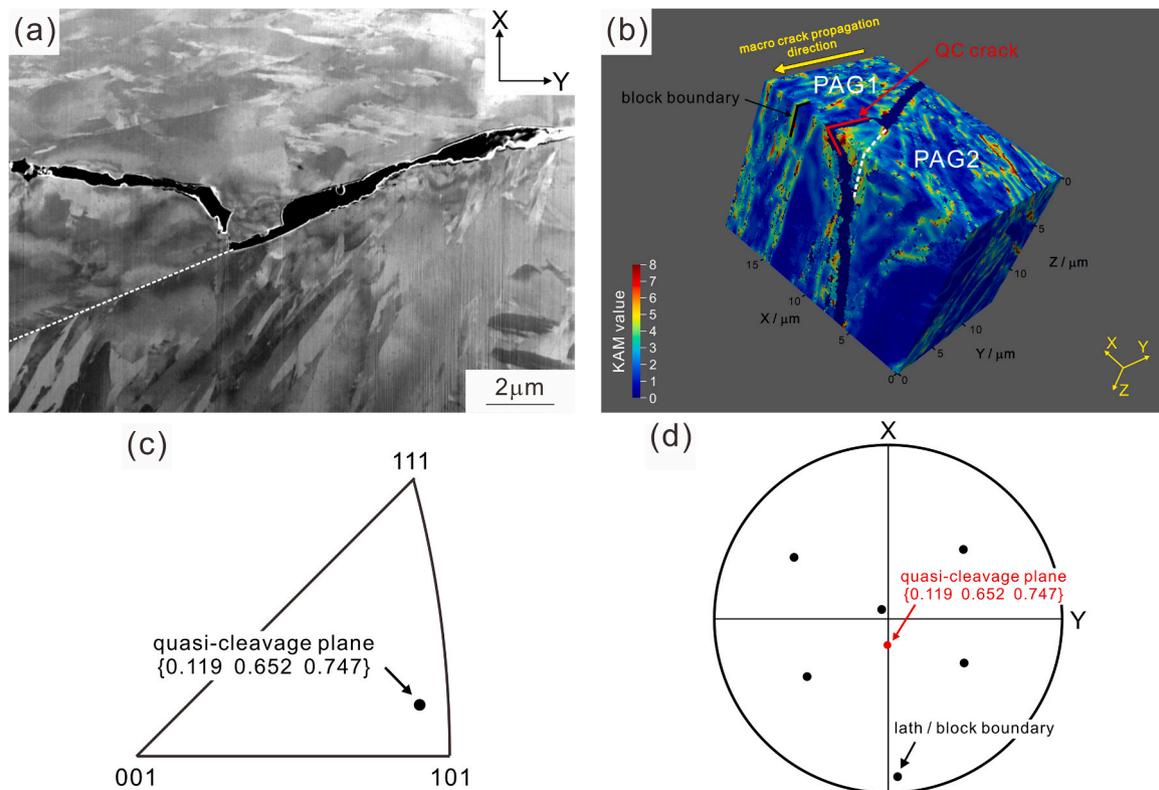
Fig. 5. (a) SEM image ($Z = 0\ \mu\text{m}$), (b) 3D-EBSD KAM map, (c) stereographic triangle showing the orientation of the quasi-cleavage crack plane, and (d) $\langle 0\ 0\ 1 \rangle$ pole figure of the hydrogen-charged specimen with $H_D = 4.00$ wt ppm. The poles of the quasi-cleavage plane and lath / block boundaries are indicated in (d).

The results of the 3D-EBSD analysis of the hydrogen-charged specimen with $H_D = 4.00$ wt ppm are shown in Fig. 5 (a) SEM image of the first section and (b) 3D-EBSD kernel average misorientation (KAM) map). KAM represents the average misorientation around a measurement point. In the present study, orientation data of the three-dimensional neighboring points surrounding a measurement point (26 points in total) were used. Higher KAM values are indicative of significant crystal rotation resulting from plastic deformation. The crack deviated from the PAGB and propagated in a quasi-cleavage manner. The crystallographic plane of the quasi-cleavage component was identified using two-surface trace analysis, and the plane normal was determined to be $\{0.119\ 0.652\ 0.747\}$, as shown in the stereographic triangle of Fig. 5(c). Although the quasi-cleavage crack plane is close to the $\{0\ 1\ 1\}$ plane, the misorientation from the $\{0\ 1\ 1\}$ plane is 7.76° . Moreover, the KAM values around the quasi-cleavage crack are remarkably high, indicating crystal rotation owing to plastic deformation (Fig. 5(b)). Because the crack plane does not coincide exactly with the $\{0\ 1\ 1\}$ plane, we can infer that the quasi-cleavage fracture is not due to atomistic cleavage fracture at the $\{0\ 1\ 1\}$ plane but to fracture macroscopically parallel to the $\{0\ 1\ 1\}$ plane, which is accompanied by large plastic deformation. As shown in the $\langle 0\ 0\ 1 \rangle$ pole figure of Fig. 5 (d), it should be emphasized that the $\{0\ 1\ 1\}$ plane selected as the quasi-cleavage fracture is different from the $\{0\ 1\ 1\}$ plane parallel to the lath and block boundaries. Therefore, we can conclude that the quasi-cleavage fracture does not originate from the decohesion at the lath /

The hydrogen-related quasi-cleavage crack propagation nearly parallel to the $\{0\ 1\ 1\}$ planes was accompanied by local plastic deformation, as confirmed by the large KAM value in the 3D-EBSD KAM map shown in Fig. 5. In addition, despite the small macroscopic J -integral value in the hydrogen-charged specimen (Fig. 2), we demonstrated, based on the analysis of dislocation microstructures, local crystal orientation changes, and dislocation densities, that the evolution of the deformation microstructure ahead of the hydrogen-related quasi-cleavage crack was remarkable compared with that accompanying the intergranular crack in the uncharged specimen, as shown in Figs. 7, 11, and 12. Previously, we investigated the effect of hydrogen on the evolution of the deformation microstructure in a low-carbon steel with a simple microstructure consisting of ferrite and pearlite using neutron diffraction and STEM analyses [61]. The fraction of screw dislocations in the uncharged specimen was significantly large (approximately 97%) at the initial stage of deformation ($e = 3\%$). This could be due to the relatively higher mobility of the non-screw dislocation segment in bcc crystal [62–66]. In contrast, the fractions of edge and screw dislocations at the initial stage of deformation ($e = 3\%$) were comparable in the hydrogen-charged specimen. Moreover, the size of LEDS tended to be smaller and the misorientation of LEDS was larger in the hydrogen-charged specimen than those in the uncharged specimen [61]. This suggests that hydrogen increases the relative mobility of screw dislocations to edge dislocations (by either decreasing the mobility of edge dislocations or increasing the mobility of screw dislocations). The recent in-situ mechanical tests in TEM [67] and the molecular dynamics simulations [68] support this idea. Huang et al. [67] reported the enhanced screw dislocation motion in α -iron by analyzing the movement of each individual dislocation. Matsumoto et al. [68] performed the molecular dynamic simulations and revealed that the movement of edge dislocations was significantly suppressed as the hydrogen concentration increased. The high relative mobility of the screw dislocations leads to frequent cutting of screw dislocations. Accordingly, we can consider that the change in the dislocation characteristics (that is, the increased relative mobility of screw dislocations) results in the remarkable evolution of the deformation microstructure around the hydrogen-related quasi-cleavage crack observed in Fig. 12, which is consistent with the finding in the previous study indicating that hydrogen facilitates the evolution of the deformation microstructure in ferritic steel with a simple microstructure [61].

quasi-cleavage fracture. However, it is sometimes difficult to distinguish between conventional cleavage fractures and quasi-cleavage fractures from the perspective of fracture surface morphology. The results shown in Figs. 5 and 8 clearly indicate that the quasi-cleavage crack planes, even microscopic facet planes, are close to the $\{011\}$ plane and not to the $\{001\}$ plane. Because several studies have reported that hydrogen also promotes cleavage fracture [34,48,49,70], hydrogen-related transgranular fractures with crack planes parallel to the $\{001\}$ could be classified as cleavage fractures rather than quasi-cleavage fractures. Considering that quasi-cleavage fracture also occurs along the $\{011\}$ plane in ferritic steel with a simple microstructure [38], we can propose that fracture along the $\{011\}$ plane is one of the most important features for characterizing hydrogen-related quasi-cleavage fractures in steels with bcc phases.

Because the crack planes depicted in Figs. 5 and 8 do not exactly align with the $\{011\}$ plane, the quasi-cleavage fracture is not originated from atomistic cleavage fracture at the $\{011\}$ plane. Though further studies should be necessary, one potential scenario of the hydrogen-related quasi-cleavage fracture is as follows. The high relative mobility of the screw dislocations results in the remarkable evolution of deformation microstructure by frequent cutting of screw dislocations (Figs. 11 and 12), consequently leading to the persistent generation of vacancies. First-principles calculations [71] have indicated that hydrogen increased the activation energy for vacancy diffusion, thereby reducing diffusivity of vacancies. As a result, the vacancies nucleated by jog-dragging of screw dislocations remained at a high density in the vicinity of the slip planes. Consequently, we can propose that the remaining high-density vacancies or nanovoids coalesced with each other, leading to a hydrogen-related quasi-cleavage fracture.

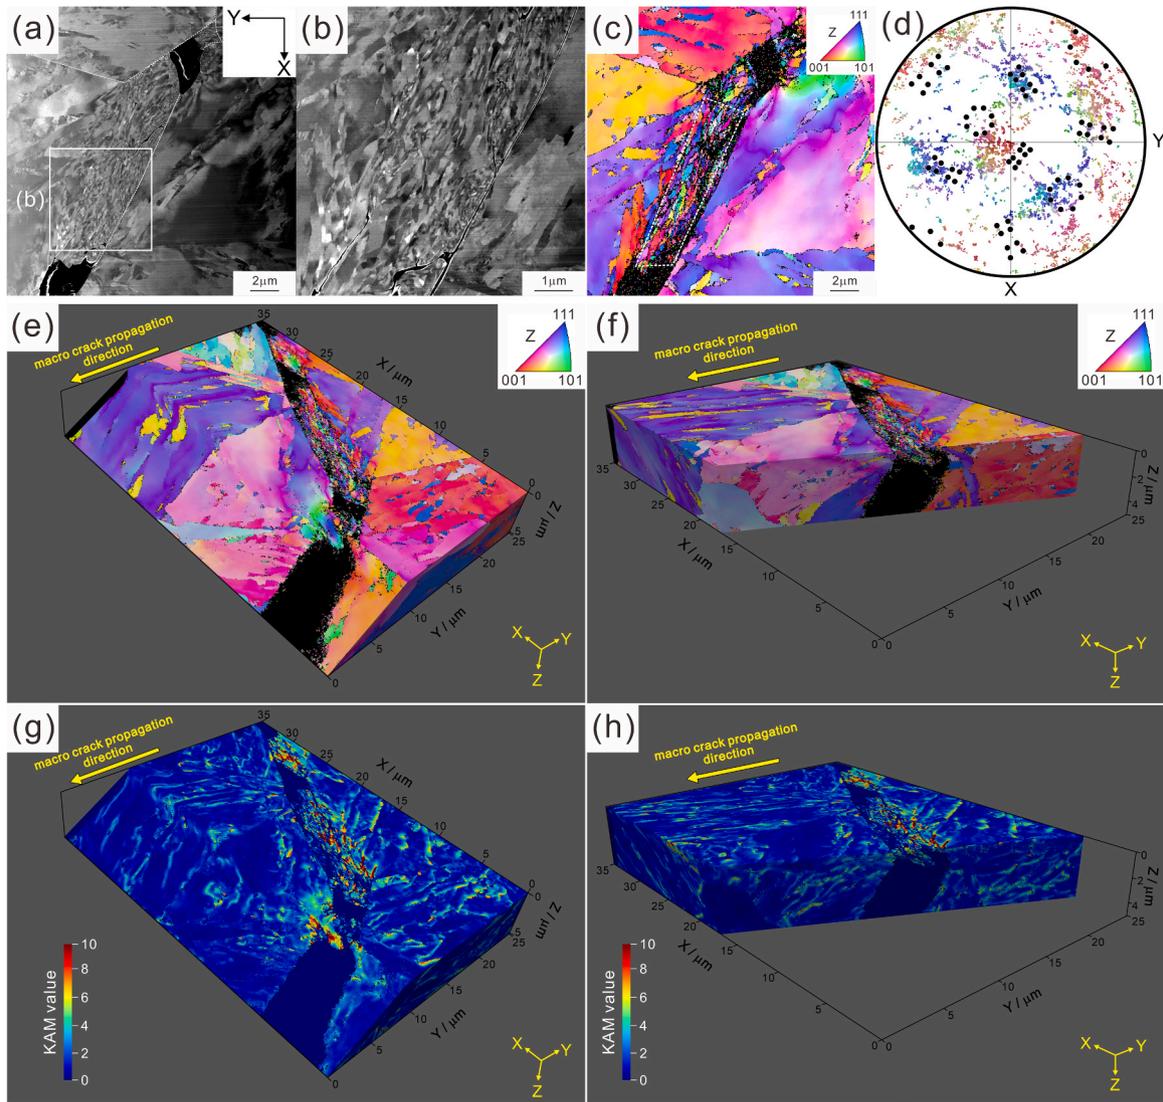
Fig. 6. (a, b) SEM images ($Z = 0 \mu\text{m}$), (c) EBSD orientation map ($Z = 0 \mu\text{m}$), (d) $\langle 0 0 1 \rangle$ pole figure of the white rectangular area in (c), on which the ideal poles of the 24 K-S variants are superimposed, (e, f) 3D-EBSD orientation maps, and (g, h) 3D-EBSD KAM maps of the hydrogen-charged specimen with $H_D = 4.00$ wt ppm.

Fig. 6 presents the 3D-EBSD analysis result in the hydrogen-charged specimen with $H_D = 4.00$ wt ppm. As shown in the low- (Fig. 6(a)) and high-magnification (Fig. 6(b)) SEM images and the EBSD orientation map (Fig. 6(c)) of the first section, an ultrafine-grained structure with a grain size less than $1\ \mu\text{m}$ formed around the intergranular crack. Fig. 6 (d) illustrates the $\langle 0\ 0\ 1 \rangle$ pole figure of the white rectangular area in (c) (the colors in the poles correspond to that in the EBSD orientation map). The orientation of parent austenite phase on the left side before the transformation was recalculated from the EBSD orientation data assuming the Kurdjumov-Sachs (K-S) orientation relationship between martensite and austenite [59]. The ideal $\langle 0\ 0\ 1 \rangle$ poles of the 24 K-S variants are indicated by black circles. Because the distribution of the $\langle 0\ 0\ 1 \rangle$ poles is different from that of the ideal 24 K-S variants, we can say that grain subdivision due to severe plastic deformation occurred around the intergranular crack. Fig. 6(e – h) presents the 3D-EBSD orientation maps and 3D-EBSD KAM maps, respectively, with arbitrary sections. The crack exhibits a large opening displacement below the ultrafine-grained region, and the KAM values are particularly high in the ultrafine-grained region. This indicates that plastic deformation sufficiently large to form an ultrafine-grained structure occurred locally at the crack tip with a large opening displacement. Although only one example is shown in this paper (Fig. 6), we have observed several arrested intergranular crack tips where an ultrafine-grained structure was formed.

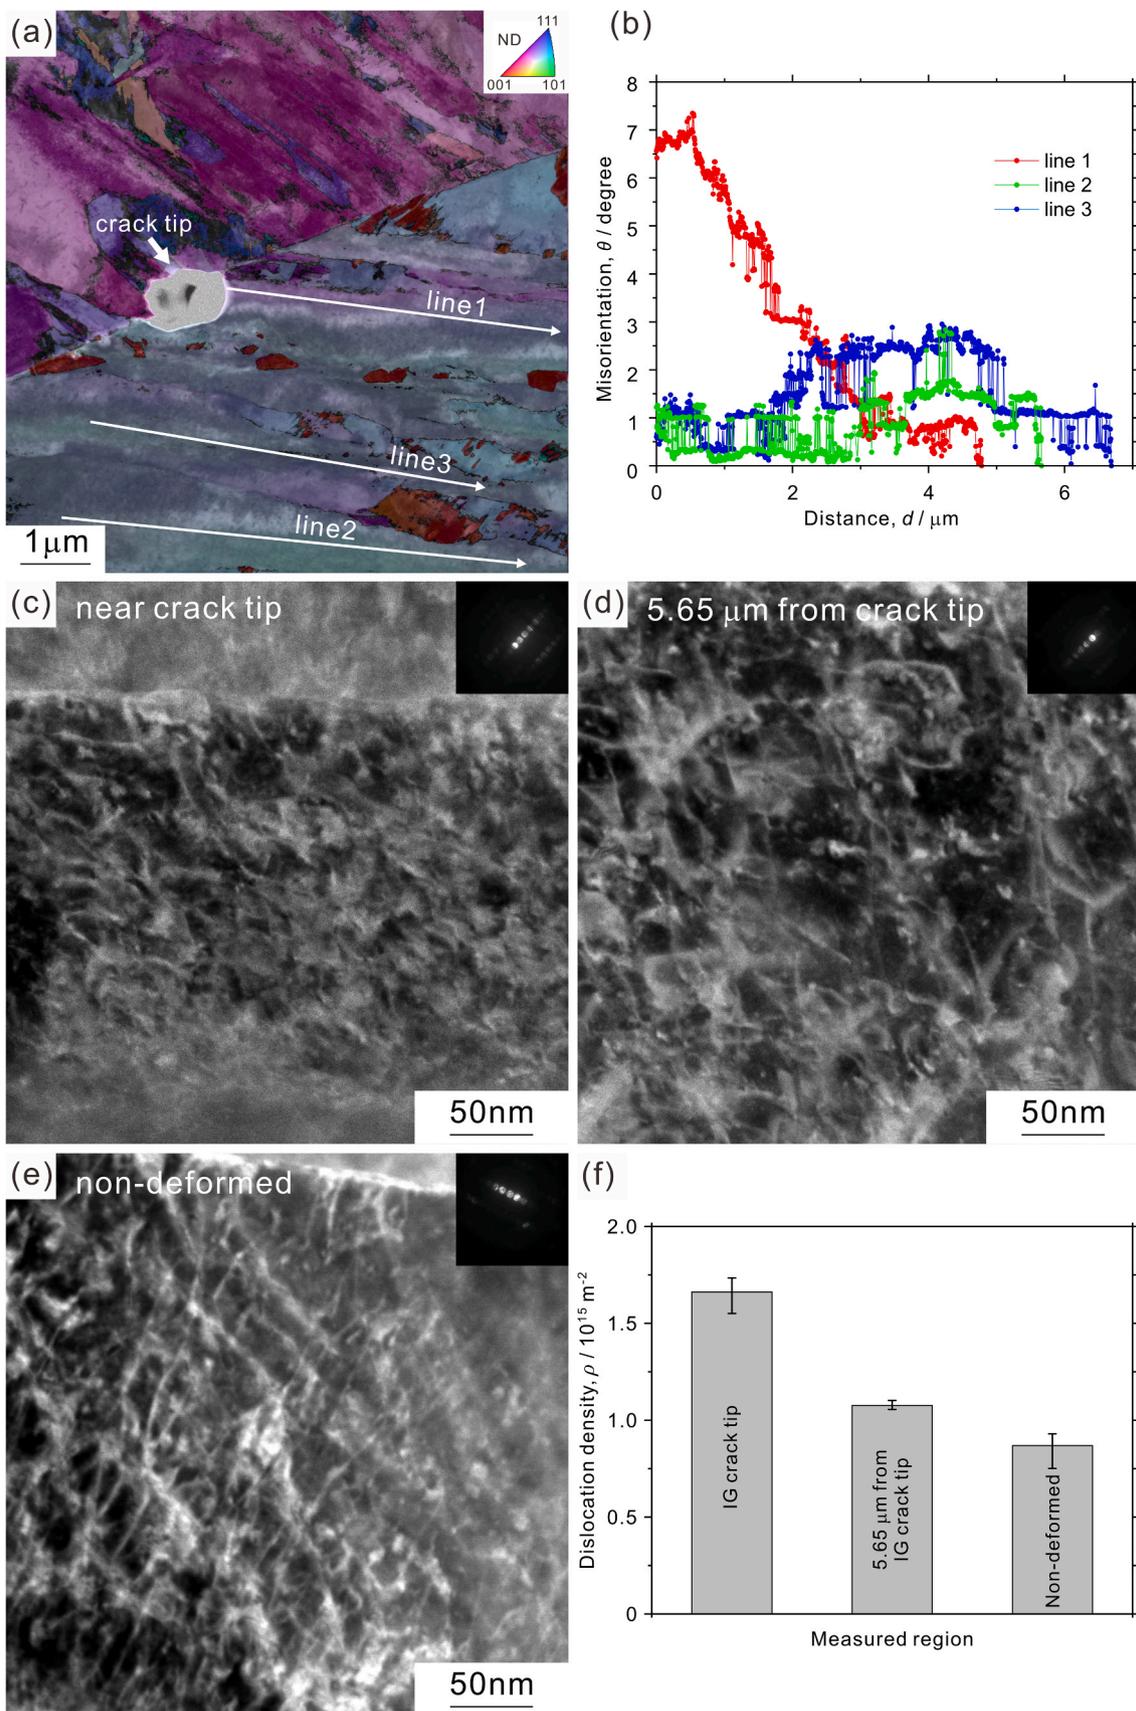
Fig. 7. (a) ACOM-TEM orientation map superimposed on the STEM image, (b) misorientation profiles along lines 1, 2, and 3, whose positions are indicated in (a), (c – e) dark-field STEM images ((c) near the crack tip, (d) 5.65 μm from the crack tip, and (e) non-deformed state), and (f) dislocation densities of each region in the uncharged specimen.

Local orientation analysis around the arrested intergranular crack in the uncharged specimen was performed using ACOM-TEM. Fig. 7(a) shows the ACOM-TEM orientation map superimposed on the STEM image near the blunted intergranular crack tip. The region around the crack was not preferentially etched, and the substructure around the

crack can be clearly observed. The color indicates the crystal orientation parallel to the normal direction of the foil plane, and the local orientation tends to change around the blunted crack tip. Fig. 7(b) shows the misorientation profiles along lines 1, 2, and 3, whose positions are indicated in (a). No significant change in the crystal orientation is visible along lines 2 and 3, which are far from the crack. In contrast, the crystal orientation along line 1 changes gradually towards the blunted crack tip by up to 7° . This indicates that plastic accommodation occurred over a relatively large area when the crack tip was blunted. Fig. 7(c – e) shows dark-field STEM images of (c) the region near the crack tip, (d) the region $5.65 \mu\text{m}$ away from the crack tip, and (e) the non-deformed (as heat-treated) state in the uncharged specimen. The observations were performed under a two-beam condition with a diffraction vector of $g^* = 0 1 1$, as indicated by the diffraction patterns inserted at the upper-right corners. Many straight dislocations are observed in the region $5.65 \mu\text{m}$ away from the crack tip (Fig. 7(d)), which are similar in the non-deformed state (Fig. 7(e)). In contrast, the dislocations near the crack tip are more curved and tangled (Fig. 7(c)), indicating that plastic accommodation occurred when the crack tip was blunted. However, the deformation microstructure did not sufficiently develop. Fig. 7(f) summarizes the dislocation densities in each region. Although the dislocation density of the non-deformed specimen is $0.9 \times 10^{15} \text{ m}^{-2}$, the

dislocation density increases up to $1.7 \times 10^{15} \text{ m}^{-2}$ towards the crack tip. Even in the region $5.65 \mu\text{m}$ away from the crack tip, the dislocation density is $1.1 \times 10^{15} \text{ m}^{-2}$, which is higher than that in the non-deformed specimen. This suggests that plastic accommodation associated with the blunting of the crack tip occurred over a relatively large region ranging several to tens of micrometers. The size of the plastic zone (r_p) estimated from fracture mechanics assuming the plane strain condition is derived using Eq.1 [60]:

where K is the stress intensity factor, and σ_y is the yield strength. The plastic zone estimated from the unloading compliance tests ($K_Q = 49.4 \text{ MPa m}^{1/2}$) is $306 \mu\text{m}$, which is considerably larger than the size confirmed by the ACOM-TEM and STEM analyses (Fig. 7). This could be because intergranular fracture in martensitic steels does not correspond to a single main crack propagation, but results from many cracks propagating with frequent branching [30,54].

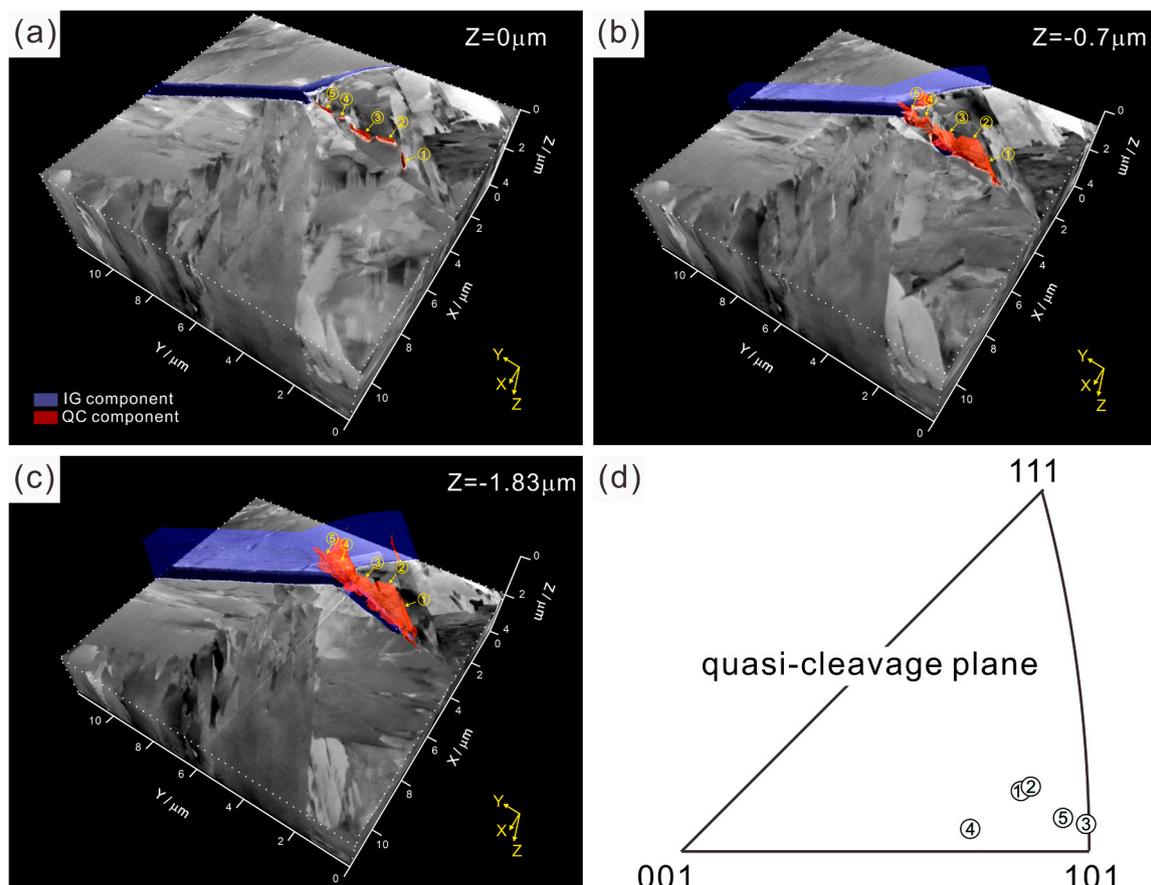
Fig. 8. (a – c) 3D crack morphology ((a) $Z = 0 \mu\text{m}$, (b) $Z = -0.7 \mu\text{m}$, and (c) $Z = -1.83 \mu\text{m}$ (blue: intergranular crack component and red: quasi-cleavage crack component)) and (d) stereographic triangle showing the orientation of the microscopic quasi-cleavage crack facets of the hydrogen-charged specimen with $H_D = 4.00 \text{ wt ppm}$.

Fig. 8(a – c) shows the 3D crack morphology (blue: intergranular crack component and red: quasi-cleavage crack component) in the hydrogen-charged specimen with $H_D = 4.00$ wt ppm. In contrast to the 3D images shown in Figs. 3-6, the section of $Z = 0 \mu\text{m}$ in Fig. 8 was set as

the final section in the FIB-SEM serial sectioning to easily understand the crack morphology. Several microscopic isolated quasi-cleavage cracks with different faceted planes (5 cracks in total) are observed at the region ahead of the intergranular crack in the section $Z = 0 \mu\text{m}$ (Fig. 8(a)). However, as shown in the $Z = -0.7 \mu\text{m}$ and $Z = -1.83 \mu\text{m}$ sections (Fig. 8(b, c)), these cracks are fully interconnected in the region below the $Z = 0 \mu\text{m}$ section. According to the 3D crack morphology, we find that the quasi-cleavage crack propagation is non-uniform changing microscopic faceted plane frequently. Fig. 8(d) shows the stereographic triangle indicating the normal directions of these microscopic facets

determined by two-surface trace analysis (the number of each pole corresponds to that of the facet in (a) – (c)). It is clear that the facets are close to the $\{0 1 1\}$ plane. However, the misorientation of some facets from the $\{0 1 1\}$ plane is large (particularly, 12.46° for facet 4), indicating that the quasi-cleavage crack does not originate from atomistic decohesion at $\{0 1 1\}$ plane. Fig. 9(a) shows a low-magnification STEM image around the crack, and the observed section is almost the same as the final section in the FIB-SEM serial sectioning (Fig. 8(a)). Although several studies reported that the quasi-cleavage cracks propagated at the lath boundaries [31–34], the high-magnification STEM images of Fig. 9

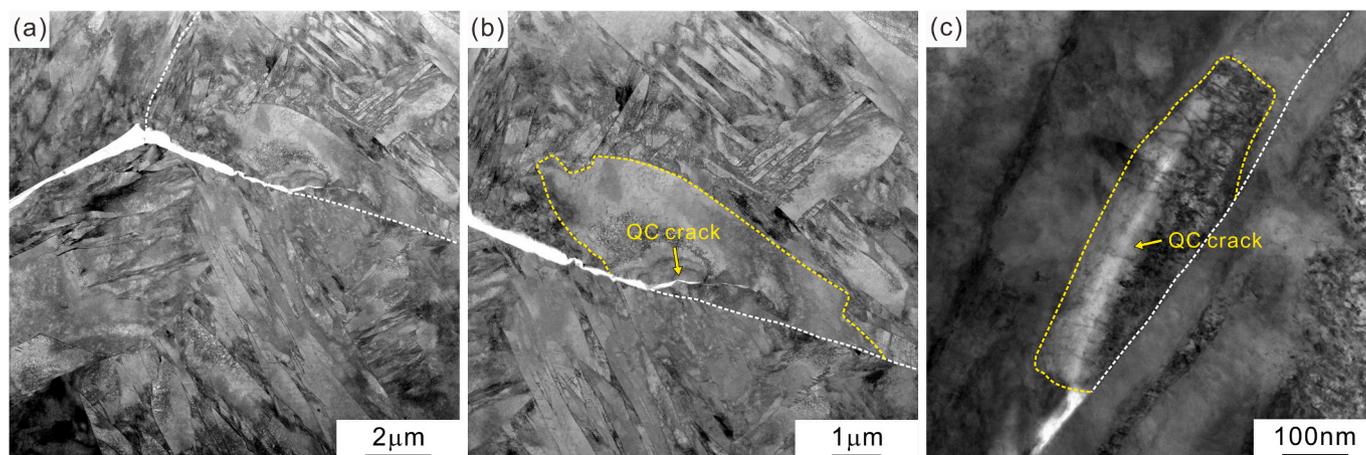
Fig. 9. STEM images of the hydrogen-charged specimen with $H_D = 4.00 \text{ wt ppm}$.

(b, c) clearly demonstrate that the quasi-cleavage crack propagation occurred inside the lath and not at the lath boundaries (the positions of the lath boundaries are indicated by the yellow-dashed lines).

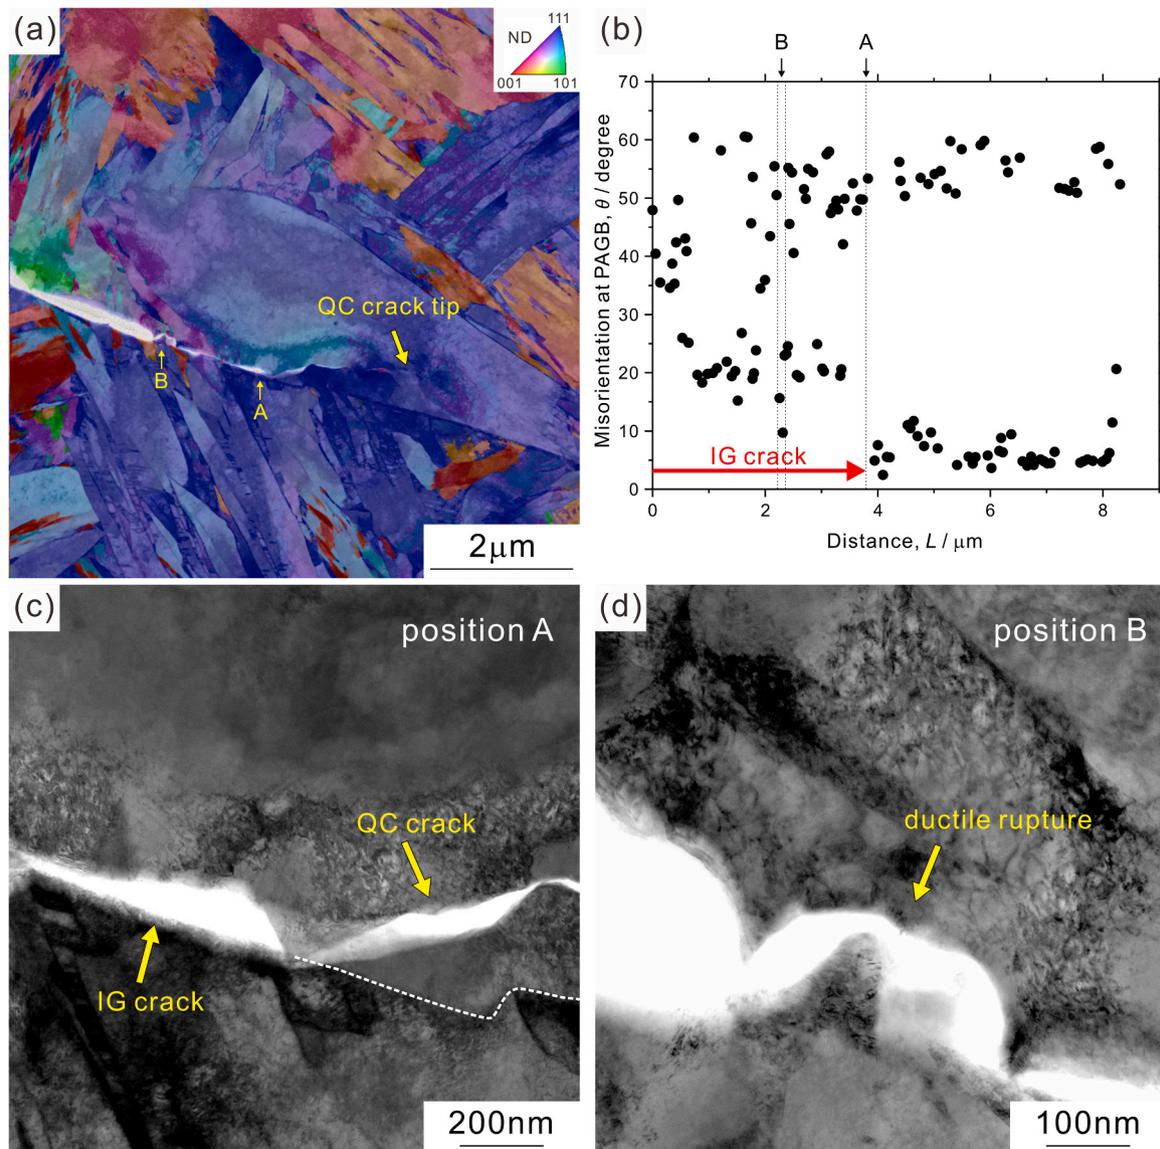
Fig. 10. (a) ACOM-TEM orientation map superimposed on the STEM image, (b) local misorientation of the prior austenite grain boundary, and (c, d) STEM images at positions A and B indicated in (a) in the hydrogen-charged specimen with $H_D = 4.00$ wt ppm.

Fig. 10 (a) is an ACOM-TEM orientation map superimposed on the STEM image, and (b) is the local misorientation of the PAGB obtained from the orientation map of (a) in the hydrogen-charged specimen with $H_D = 4.00$ wt ppm. The crack deviated from the PAGB at position 'A' and propagated as a quasi-cleavage crack, as shown in Fig. 10 (c). In the region ahead of position 'A', a substantial portion of PAGB segments exhibit a misorientation of less than 10° . Additionally, we can confirm the evidence of ductile rupture at position 'B' (Fig. 10 (d)). The misorientation of the PAGB segment at position 'B' is also small. Consequently, the crack propagation into the PAG interior and the ductile rupture occurred at the low-angle PAGB segments, indicating that the low-angle PAGB segments provide strong resistance to intergranular crack propagation.

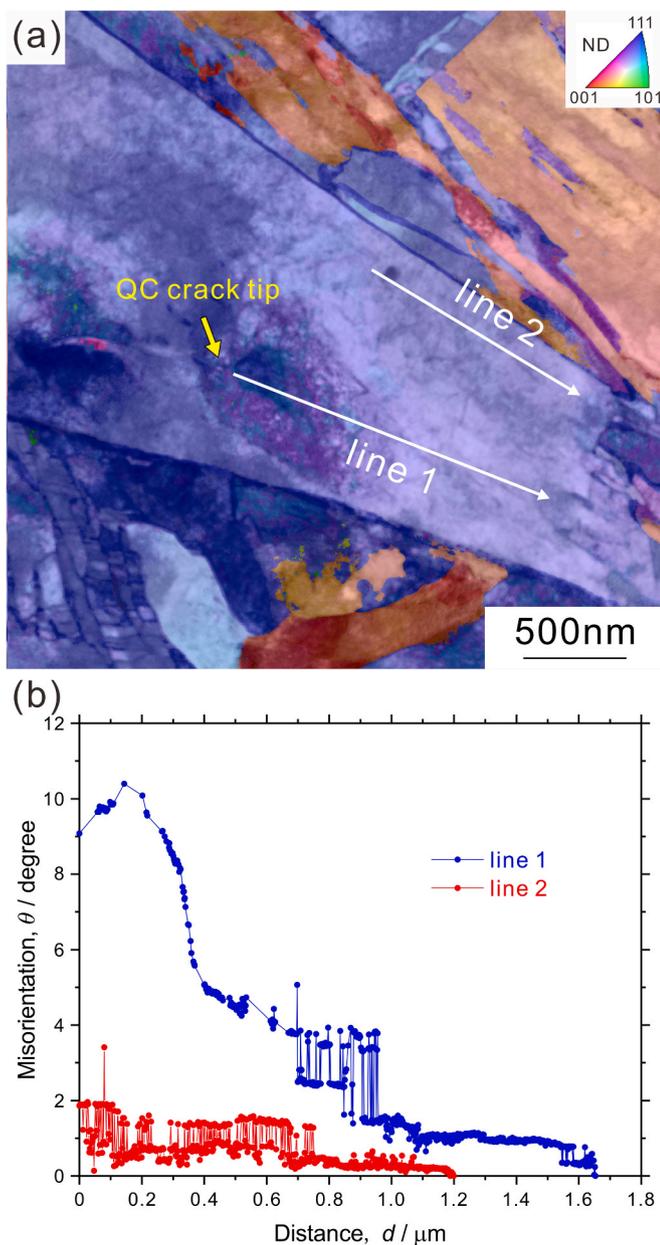
Fig. 11. (a) ACOM-TEM orientation map superimposed on the STEM image and (b) misorientation profiles along lines 1 and 2, whose positions are indicated in (a), in the hydrogen-charged specimen with $H_D = 4.00$ wt ppm.

The results of the local orientation analysis in the hydrogen-charged specimen with $H_D = 4.00$ wt ppm are shown in Fig. 11 ((a) ACOM-TEM orientation map superimposed on the STEM image and (b) misorientation profiles along lines 1 and 2 in (a)). The analyzed region corresponds to the area around the quasi-cleavage crack tip depicted in Fig. 10 (a).

Although the misorientation along line 2, which is far from the crack, is approximately 2° , the orientation changes significantly up to 10° towards the crack tip within $1\ \mu\text{m}$ along line 1. Therefore, in the hydrogen-related quasi-cleavage fracture, plastic accommodation occurred in a localized region around the crack tip. Furthermore, the plastic accommodation region is considerably smaller than the plastic zone estimated using Eq. 1 ($35\ \mu\text{m}$ when using $K_Q = 16.7\ \text{MPa}\ \text{m}^{1/2}$). The dark-field STEM images in the hydrogen-charged specimen with $H_D = 4.00$ wt ppm are shown in Fig. 12 ((a) the region near the quasi-cleavage crack tip, (b) the region $1.58\ \mu\text{m}$ away from the quasi-cleavage crack, (c) the wake region of the quasi-cleavage crack, and (d) the wake region of the intergranular crack). In the vicinity of the quasi-cleavage crack tip, so-called low-energy dislocation structures (LEDS) as well as curved and tangled dislocations are observed (Fig. 12 (a)). In contrast, the microstructure in the region $1.58\ \mu\text{m}$ away from the quasi-cleavage crack tip (Fig. 12 (b)) is similar to that of the non-deformed specimen (Fig. 7(e)). This is consistent with the orientation change significantly localized near the crack tip, as shown in Fig. 11. A well-developed deformation microstructure, that is, LEDS and curved / tangled dislocations, is also observed in the wake region of the quasi-cleavage crack (Fig. 12 (c)). This indicates that the hydrogen-related quasi-cleavage crack
