Local crack arrestability and deformation microstructure evolution of hydrogen-related fracture in martensitic steel

Akinobu Shibata^{a,b,*}, Ivan Gutierrez-Urrutia^a, Akiko Nakamura^c, Taku Moronaga^c, Kazuho Okada^a, Yazid Madi^d, Jacques Besson^d, Toru Hara^a

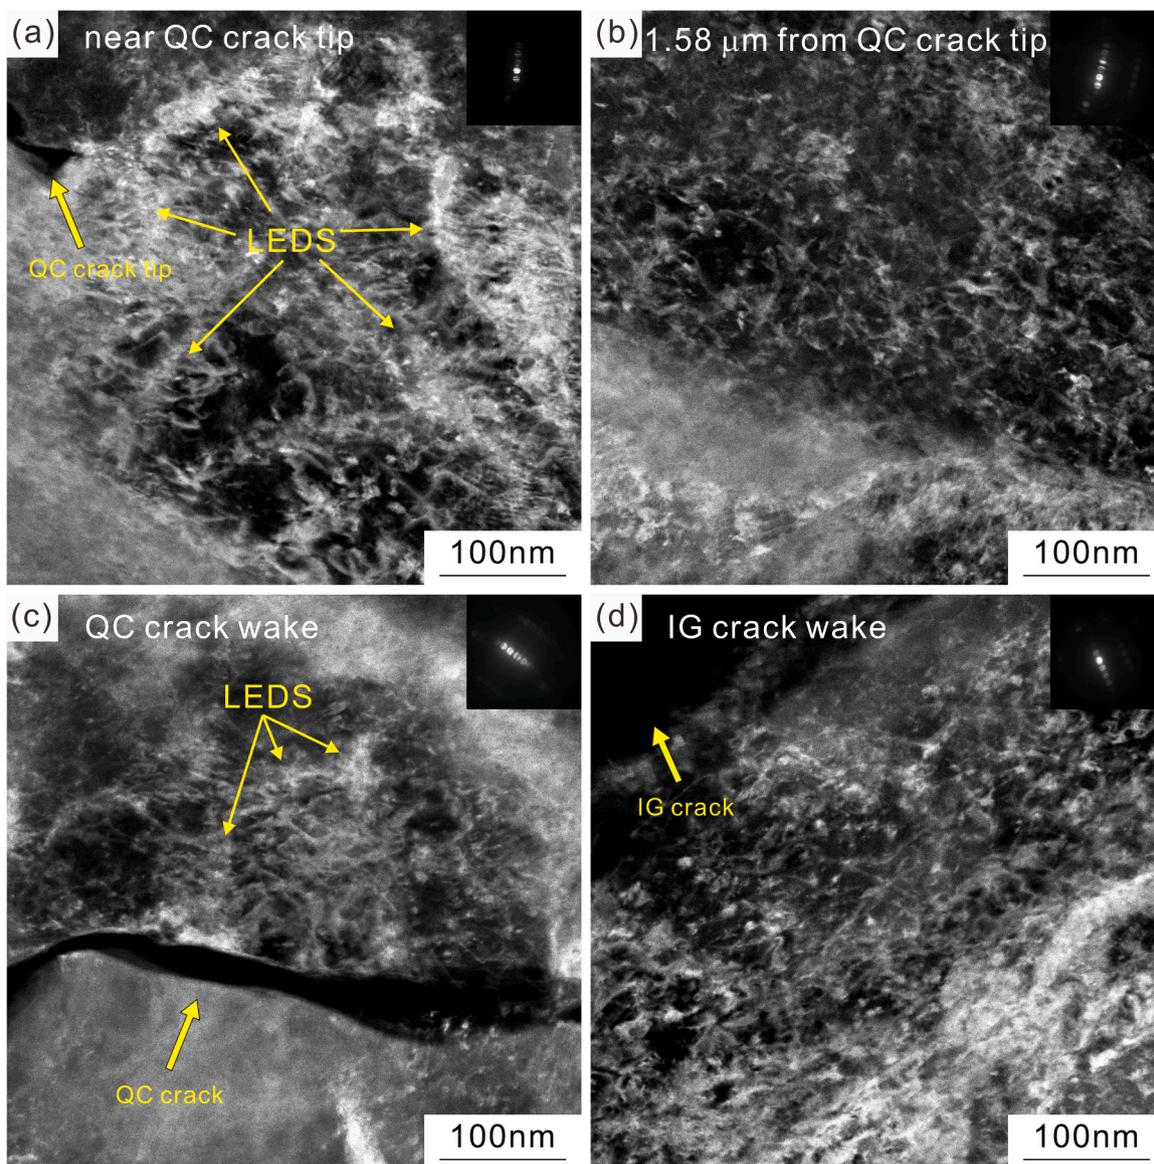
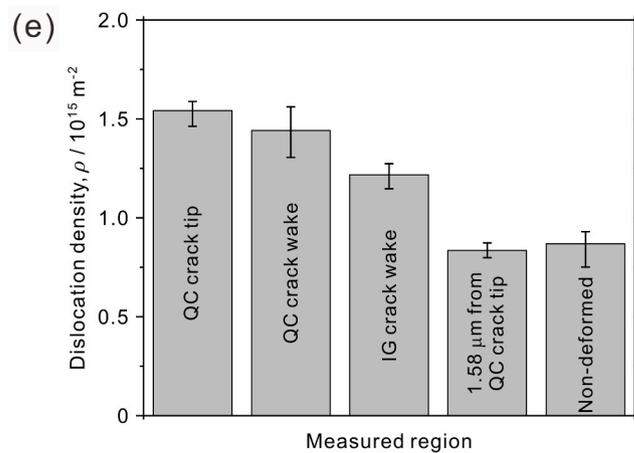
Fig. 12. (a – d) Dark-field STEM images ((a) near the quasi-cleavage crack tip, (b) 1.58 μm from the quasi-cleavage crack tip, (c) wake of the quasi-cleavage crack, and (d) wake of the intergranular crack), and (e) dislocation densities of each region in the hydrogen-charged specimen with $H_D = 4.00$ wt ppm.

Although the misorientation along line 2, which is far from the crack, is approximately 2° , the orientation changes significantly up to 10° towards the crack tip within $1\ \mu\text{m}$ along line 1. Therefore, in the hydrogen-related quasi-cleavage fracture, plastic accommodation occurred in a localized region around the crack tip. Furthermore, the plastic accommodation region is considerably smaller than the plastic zone estimated using Eq. 1 ($35\ \mu\text{m}$ when using $K_Q = 16.7\ \text{MPa}\ \text{m}^{1/2}$). The dark-field STEM images in the hydrogen-charged specimen with $H_D = 4.00$ wt ppm are shown in Fig. 12 ((a) the region near the quasi-cleavage crack tip, (b) the region $1.58\ \mu\text{m}$ away from the quasi-cleavage crack, (c) the wake region of the quasi-cleavage crack, and (d) the wake region of the intergranular crack). In the vicinity of the quasi-cleavage crack tip, so-called low-energy dislocation structures (LEDS) as well as curved and tangled dislocations are observed (Fig. 12 (a)). In contrast, the microstructure in the region $1.58\ \mu\text{m}$ away from the quasi-cleavage crack tip (Fig. 12 (b)) is similar to that of the non-deformed specimen (Fig. 7(e)). This is consistent with the orientation change significantly localized near the crack tip, as shown in Fig. 11. A well-developed deformation microstructure, that is, LEDS and curved / tangled dislocations, is also observed in the wake region of the quasi-cleavage crack (Fig. 12 (c)). This indicates that the hydrogen-related quasi-cleavage crack

propagation was accompanied by a remarkable evolution of the deformation microstructure. On the other hand, tangled dislocations are partially observed around the intergranular crack in Fig. 12 (d). Fig. 12 (e) summarizes the dislocation densities in each region. While the dislocation densities are high at the tip of the quasi-cleavage crack ($1.5 \times 10^{15} \text{ m}^{-2}$) and the wake region of the quasi-cleavage crack ($1.4 \times 10^{15} \text{ m}^{-2}$), the dislocation density at a distance of $1.58 \mu\text{m}$ from the crack tip decreases to $0.8 \times 10^{15} \text{ m}^{-2}$, which is almost the same as that in the non-deformed specimen ($0.9 \times 10^{15} \text{ m}^{-2}$). Therefore, we can say that the plastic deformation was significantly localized in the vicinity of the quasi-cleavage crack from the viewpoint of dislocation densities. The dislocation density around the intergranular crack is $1.2 \times 10^{15} \text{ m}^{-2}$, which is higher than that of the non-deformed specimen, indicating that the intergranular crack propagation was also accompanied by a certain amount of plastic deformation.

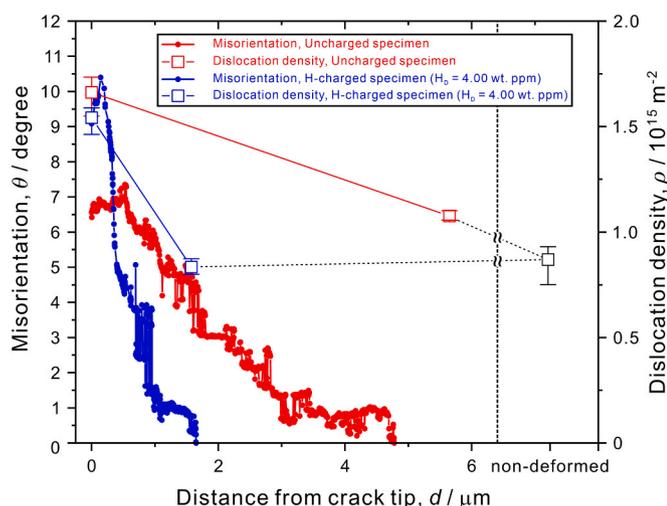
Fig. 13. Local misorientation and dislocation density plotted as a function of distance from the crack tip in the uncharged specimen (red) and the hydrogen-charged specimen with $H_D = 4.00$ wt ppm (blue).

Fig. 13 presents a summary of the local misorientation and dislocation density around the crack tip based on the results shown in Figs. 7, 11, and 12. The misorientation and dislocation density are plotted as a function of the distance from the crack tip in the uncharged specimen (red) and the hydrogen-charged specimen with $H_D = 4.00$ wt ppm (blue). In the uncharged specimen, the orientation changes gradually towards the crack tip, and the dislocation density increases as the crack tip is approached. The dislocation density is higher than that of the non-deformed state, even at a distance of $5.65 \mu\text{m}$ from the crack tip, indicating that plastic accommodation occurred over a relatively large area. In the hydrogen-charged specimen, the orientation changes abruptly within $1 \mu\text{m}$ of the crack tip. The dislocation density is high near the crack tip, and deformation microstructures, such as LEDS formations, are developed. The dislocation density decreases abruptly at $1.58 \mu\text{m}$ from the crack tip and is almost the same as that in the non-deformed state. Therefore, the plastic accommodation region in the hydrogen-charged specimen is significantly smaller than that in the uncharged specimen. One possible reason for this is the difference in the macroscopic applied load ($K_Q = 49.4$ for the uncharged specimen and $K_Q = 16.7 \text{ MPa m}^{1/2}$ for the hydrogen-charged specimen with $H_D = 4.00$ wt ppm (Fig. 2(b)). The plastic accommodation region in both the uncharged and hydrogen-charged specimens estimated from the STEM

analysis is approximately one-thirtieth of the plastic zone derived from fracture mechanics using Eq. 1. If the plastic accommodation around the crack tip depends only on the macroscopic applied load (stress intensity factor), the misorientation profile should have a similar shape. However, as shown in Fig. 13, the orientation change around the hydrogen-related quasi-cleavage crack is significantly greater than that of the uncharged specimen. Additionally, the development of deformation microstructures, such as LEDS formations, are remarkable in the hydrogen-charged specimen (Fig. 12). Therefore, we suggest that hydrogen induces intense strain localization around the crack tip. The hydrogen-related intergranular crack propagation also involves plastic deformation because the dislocation density around the intergranular crack is higher than that in the non-deformed state, as shown in Fig. 12. Moreover, plastic deformation sufficiently large to form an ultrafine-grained structure sometimes occurred locally at the tip of an arrested intergranular crack with a large opening displacement (Fig. 6). Therefore, we can conclude that intense local plastic deformation is involved in the hydrogen-related crack propagation (both quasi-cleavage and intergranular).

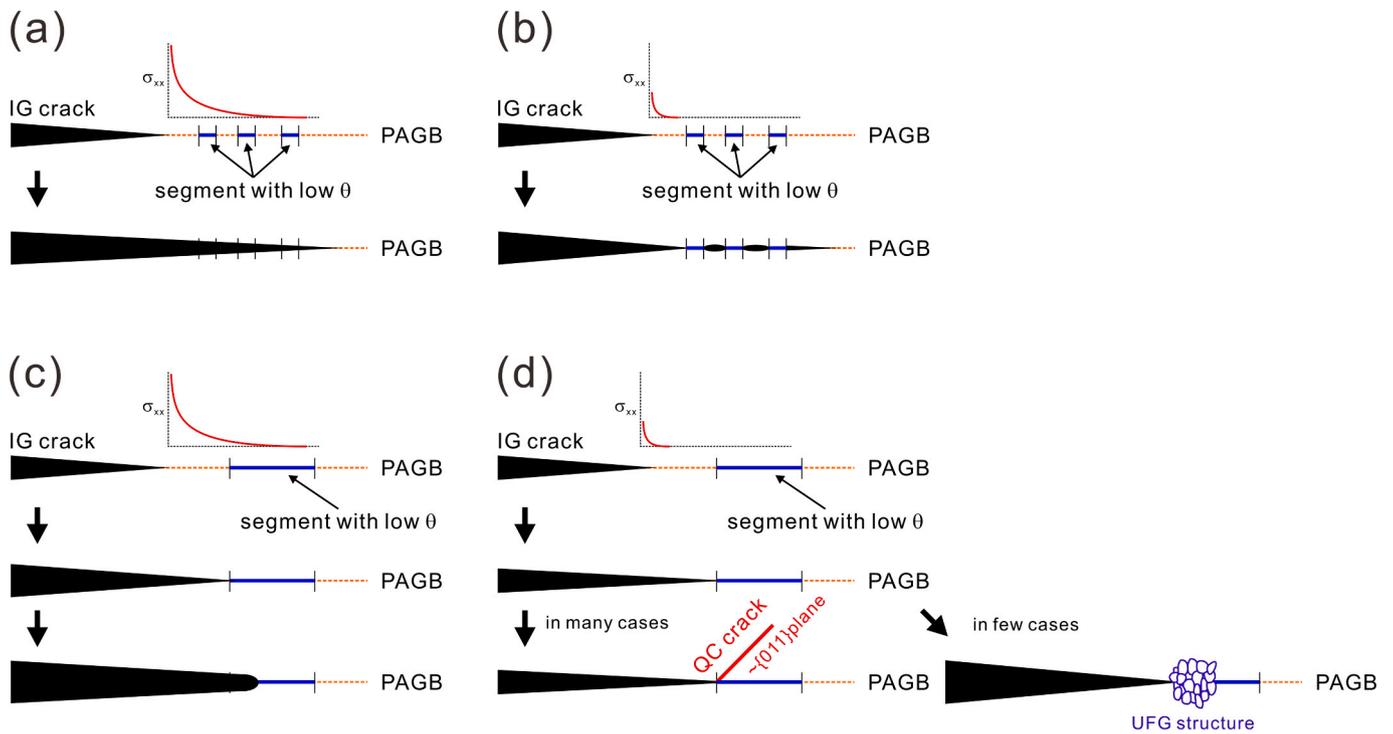
Fig. 14. Schematic illustration showing the effect of a low-angle boundary segment on the crack propagation in the (a, c) uncharged specimen and (b, d) hydrogen-charged specimen.

In addition to the previous studies [30,47], the results shown in Figs. 3, 4 and 10 clearly demonstrate that the low-angle PAGB segments impeded intergranular crack propagation. Here, we discuss the effect of low-angle PAGB segments with a relatively small size on intergranular crack propagation (Fig. 14 (a, b)). For the uncharged specimen, the crack propagates under a large load, and the stress concentration area around the crack tip is large. Therefore, even when the crack reaches a

low-angle PAGB segment with a small size, it has little effect on the crack propagation, resulting in continuous crack propagation (Fig. 14 (a)). For the hydrogen-charged specimen, even when the size of the low-angle PAGB segment is small, the segment can impede crack propagation owing to the small stress concentration range (Fig. 14 (b)). Furthermore, this behavior is also associated with the hydrogen accumulation behavior. Previously, hydrogen microprint analysis indicated that deformation promoted hydrogen accumulation around the PAGBs [72, 73]. Generally, the segregation of impurities at the grain boundary decreases as the grain boundary misorientation decreases [79]. Although the local hydrogen distribution is difficult to quantitatively evaluate (in particular, the distribution of diffusible hydrogen), it can be speculated that the local concentration of hydrogen around the low-angle PAGB segments is expected to be lower than that around the high-angle PAGB segments. The low hydrogen concentration could suppress the degradation of the cohesive energy of the PAGB segments. As described above, the reduction in the cohesive energy by hydrogen is more pronounced at the higher-energy grain boundaries [69]. Namely, the presence of hydrogen increases the difference in the cohesive energy between low-angle and high-angle PAGB segments. Therefore, the high-angle PAGB segments are preferentially cracked, while the low-angle PAGB segments still exhibit high resistance to cracking, leading to discontinuous crack propagation as shown in Fig. 4. This could elucidate why even low-angle PAGB segments with small size, specifically sub-micrometer size, can impede the propagation of hydrogen-related crack. As shown in Fig. 1, sulfur is segregated in the PAGB. If the main reason for the discontinuous crack propagation is sulfur segregation depending on grain boundary character, intergranular crack propagation behavior should be the same between the uncharged specimen and hydrogen-charged specimen. Because the obstacle effect of low-angle PAGB segments with a small size can be observed only in the hydrogen-charged specimen, it is reasonable to consider that the presence of hydrogen played a primary role on the crack propagation behavior depicted in Fig. 4.

Next, we discuss the effect of low-angle PAGB segments that are relatively large in size (Fig. 14 (c, d)). In both uncharged and hydrogen-

charged specimens, the low-angle PAGB segment with a relatively large size impedes crack propagation. Plastic accommodation and resultant crack tip blunting occur in the uncharged specimen (Fig. 14 (c)). The crack tip blunting increases the resistance to crack propagation, resulting in the arrest of the crack. The un-cracked ligaments are then fractured in a ductile manner at a later fracture process. For the hydrogen-charged specimen, even if the size of the low-angle PAGB segment is sufficiently large to prevent crack propagation, obvious crack tip blunting does not occur [47]. In many cases, the crack can continue propagating inside the PAG in a quasi-cleavage manner (Fig. 14 (d)). The propagation of the quasi-cleavage cracks is accompanied by the development of pronounced deformation microstructures (Fig. 12). In other words, cracks can propagate within the PAG even after the intergranular crack propagation has stopped. When the crack reaches another PAGB, it propagates again in an intergranular manner. On the contrary, when the arrested intergranular crack cannot propagate further within the grain as a quasi-cleavage crack, resulting in a notably large opening displacement in the wake region, plastic deformation large enough to form an ultrafine-grained structure occurs at the arrested crack tip (Figs. 6 and 14 (d)). Accordingly, we can propose that, due to the intense localized plastic work involved in the arrest of intergranular cracks (Fig. 6) and the propagation of quasi-cleavage cracks (Figs. 11 and 12), there exists a certain degree of resistance to crack propagation (intrinsic crack growth resistance), even in the case of high hydrogen concentrations (Fig. 2).
