# Quantitative analysis of local plasticity accompanying hydrogen-related fracture in low-carbon martensitic steel

Xiaodong Lan<sup>\*</sup>, Kazuho Okada, Ivan Gutierrez-Urrutia, Akinobu Shibata

Research Center for Structural Materials, National Institute for Materials Science, 1-2-1 Sengen, Tsukuba, Ibaraki, 305-0047, Japan

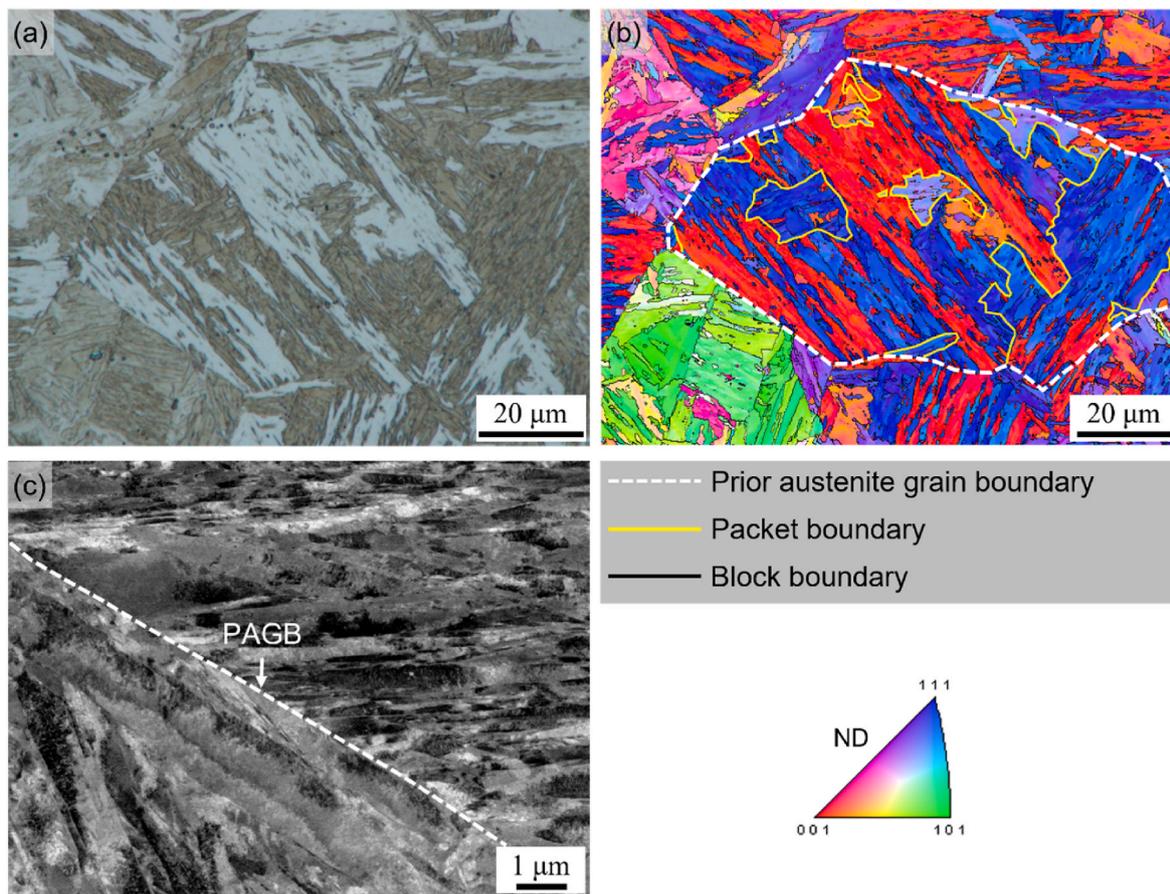
Fig. 1. (a) Optical microscopy image, (b) IPF map of the same area as (a), and (c) BSE image of the as-quenched specimen.

Fig. 1 shows (a) an optical microscopy image, (b) the corresponding inverse pole figure (IPF) map, and (c) a BSE image of the as-quenched specimen. The colors in the IPF map express the orientations parallel to the normal direction (ND) of the observed section according to the stereographic triangle presented below the IPF map. In the IPF map, the block boundaries, packet boundaries, and PAGBs determined by the orientation analysis are indicated by the black lines, yellow lines, and white dashed lines, respectively. The internal lath structures and PAGB can be observed in the high magnification BSE image (Fig. 1c). The microstructure observation results confirm that the as-quenched specimen exhibits a fully lath martensite structure consisting of blocks and packets inside each prior austenite grain.

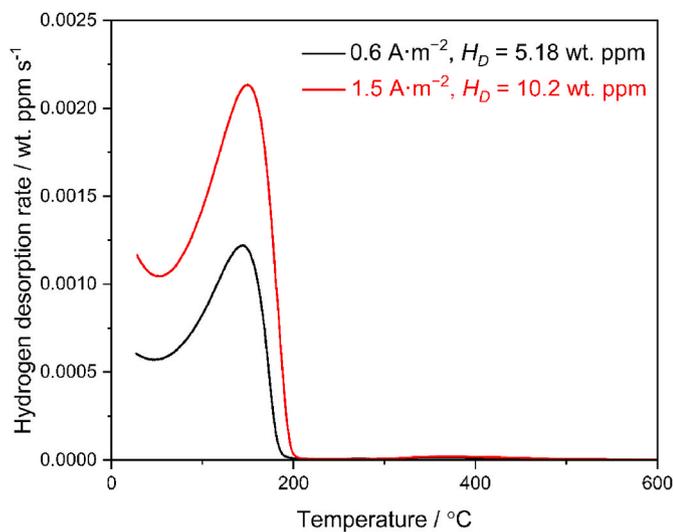
Fig. 2. Desorption profiles of the hydrogen-charged specimens at charging current densities of  $0.6 \text{ A m}^{-2}$  (black) and  $1.5 \text{ A m}^{-2}$  (red). (For interpretation of the references to color in this figure legend, the reader is referred to the Web version of this article.)

Fig. 2 shows typical desorption profiles of the hydrogen-charged specimens obtained by TDA. The  $H_D$  of the specimens charged at 0.6 A m<sup>-2</sup> and 1.5 A m<sup>-2</sup> were 5.18 wt ppm and 10.2 wt ppm, respectively. The similar shape of the desorption profiles suggests that the hydrogen

trapping / distribution behavior did not change when the current density was increased from  $0.6 \text{ A m}^{-2}$  to  $1.5 \text{ A m}^{-2}$ .

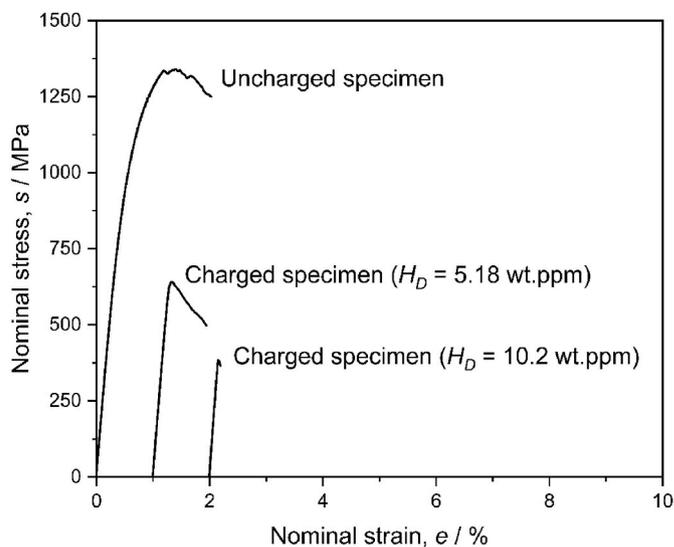
Fig. 3. Nominal stress – nominal strain curves for the uncharged and hydrogen-charged specimens with different  $H_D$ .

Fig. 3 presents the nominal stress – nominal strain curves for the

uncharged and hydrogen-charged specimens with different  $H_D$ . In this study, the nominal stress was calculated from  $F / A_0$ , where  $F$  is the applied load and  $A_0$  is the initial cross-sectional area at the notch root. The maximum flow stresses are 1341 MPa (uncharged specimen), 641 MPa (hydrogen-charged specimen with  $H_D = 5.12 \text{ wt ppm}$ ), and 384 MPa (hydrogen-charged specimen with  $H_D = 10.2 \text{ wt ppm}$ ). The fracture strains are 1.4 %, 0.34 %, and 0.16 %, respectively. The uncharged

specimen exhibited some plasticity before fracture, while the hydrogen-charged specimens with  $H_D = 5.12$  wt ppm and  $H_D = 10.2$  wt ppm were fractured within the apparent elastic regimes. Both the tensile strength and tensile ductility of the specimens decreased significantly with increasing  $H_D$ .

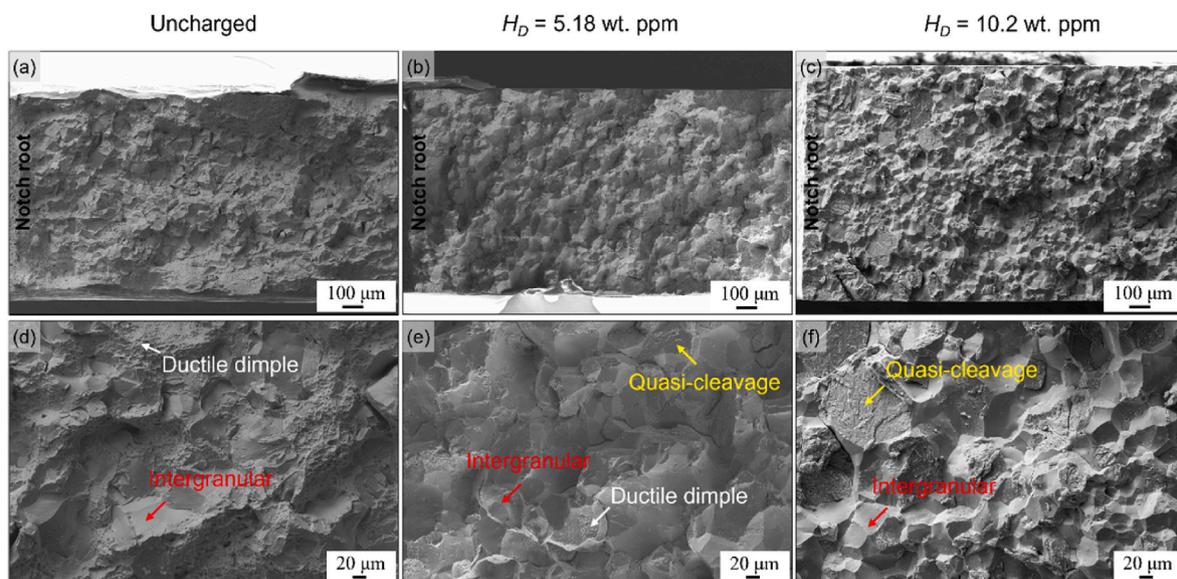
Fig. 4. SEM images showing the fracture surfaces of the (a, d) uncharged specimen, (b, e) hydrogen-charged specimen with  $H_D = 5.18$  wt ppm, and (c, f) hydrogen-charged specimen with  $H_D = 10.2$  wt ppm. The ductile dimple, quasi-cleavage surface, and intergranular surface are indicated by the white, yellow, and red arrows, respectively. (For interpretation of the references to color in this figure legend, the reader is referred to the Web version of this article.)

Fig. 4 shows SEM images of the fracture surfaces of the uncharged and hydrogen-charged specimens after tensile tests. Fig. 4a–c exhibits the low-magnification SEM images taken immediately beneath the notch root. In the magnified images (Fig. 4d–f), the positions of the typical ductile dimple, quasi-cleavage surface, and intergranular surface are indicated by the white, yellow, and red arrows, respectively. As shown in Fig. 4d, the fracture surface of the uncharged specimen was mainly covered by ductile dimples. In addition to the dimples, some areas of the fracture surface exhibit intergranular fracture features. This is the characteristic of the present martensitic steel, i.e., even in the uncharged state, large stress concentration at the notch root induces brittle intergranular fracture. The fracture surface of the hydrogen-charged specimen with  $H_D = 5.18$  wt ppm is composed of ductile dimple, quasi-cleavage surface, and intergranular surface, as shown in Fig. 4e. In the hydrogen-charged specimen with  $H_D = 10.2$  wt ppm (Fig. 4f), the fracture morphology shows a large fraction of intergranular surface. The area fraction of intergranular fracture regions increases with increasing  $H_D$ .

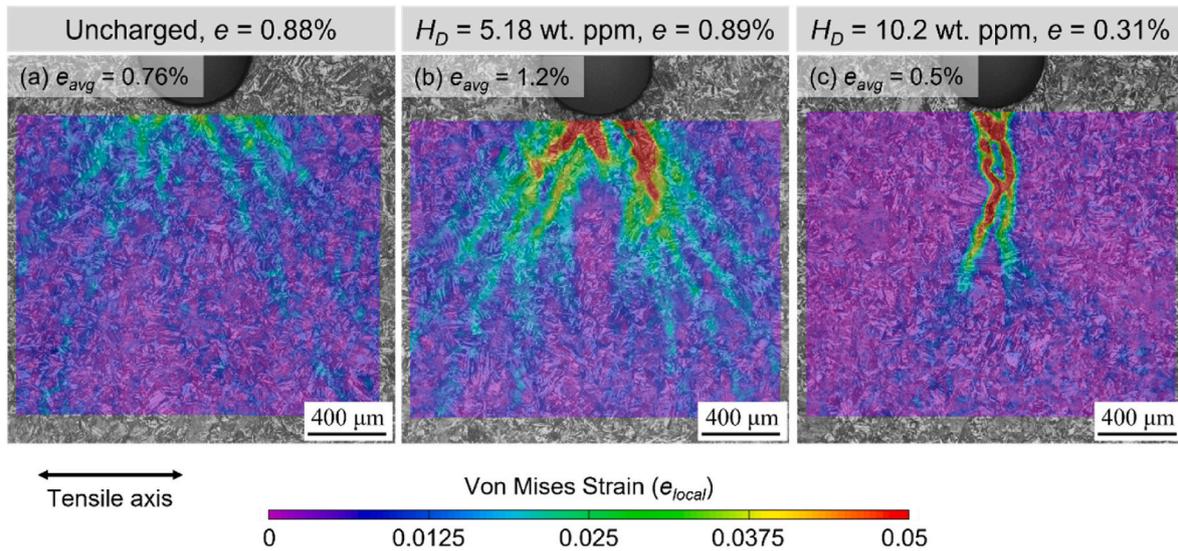
**Fig. 5.** Large field-of-view strain distribution maps in the specimens with different hydrogen contents (a) uncharged specimen,  $e = 0.88\%$ ,  $e_{avg} = 0.76\%$ , (b) hydrogen-charged specimen with  $H_D = 5.18$  wt ppm,  $e = 0.89\%$ ,  $e_{avg} = 1.2\%$ , (c) hydrogen-charged specimen with  $H_D = 10.2$  wt ppm,  $e = 0.31\%$ ,  $e_{avg} = 0.5\%$ .

The large field-of-view strain distribution maps superimposed on optical microscopy images are presented in Fig. 5. The average strain  $\epsilon_{avg}$  (as indicated in each figure) of the analyzed area was close to the nominal strain, indicating that the result was reliable. Obviously, strain localization occurred around the notch root in both the uncharged and hydrogen-charged specimens during deformation. We can find that the strain localization was enhanced in the presence of hydrogen (Fig. 5b and c).

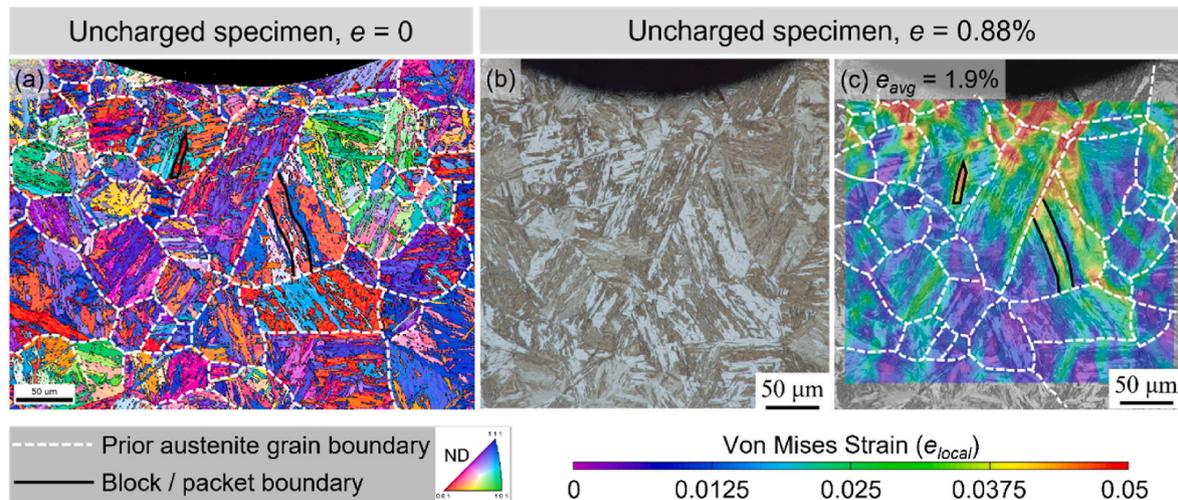
**Fig. 6.** Results of the correlative analysis for the uncharged specimen at a nominal strain level of 0.88%. (a) IPF map obtained before deformation, (b) optical microscopy image after deformation, (c) strain distribution map by DIC analysis.

In order to determine the positions of strain localization with higher spatial resolution, we analyzed the meso-scale strain distribution map covering several prior austenite grains. Fig. 6 shows (a) the IPF map of the notch root area at the undeformed state, (b) the corresponding optical microscopy image at a nominal strain level of 0.88 %, and (c) the strain distribution map superimposed on the optical microscopy image of the uncharged specimen. The boundaries identified by EBSD analysis are superimposed on the figure, and the black lines and white dashed lines indicate block / packet boundaries and PAGBs, respectively. It was observed that the uncharged specimen was deformed in a highly heterogeneous manner. No cracks were detected at this strain level. The correlative analysis of DIC strain map and IPF map shows that upon deformation, strain localization (elongated ‘band-like’ morphology) appears in the bulk of the martensite blocks, also particularly at some PAGBs. The deformation bands mainly elongate parallel to the longitudinal direction of the block. The representative strain localization positions in the bulk of the martensite blocks are highlighted by the bold black lines in both the IPF map (Fig. 6a) and the DIC strain map (Fig. 6c).

Here we discuss the observed strain localization behavior and the role of local plasticity associated with hydrogen-related fracture. For the uncharged specimen, as shown in Fig. 6c, strain localization occurred mainly in the bulk of the martensite blocks and at some PAGBs, exhibiting distinct characteristics in relation to martensitic microstructure features. For the former, the local deformation bands, which are mainly elongated parallel to the longitudinal direction of the blocks, could be explained by the activation of the in-lath-plane slip system, whose slip direction lies on the lath boundary plane. This observation was in good agreement with previous studies analyzing the characteristics of the slip

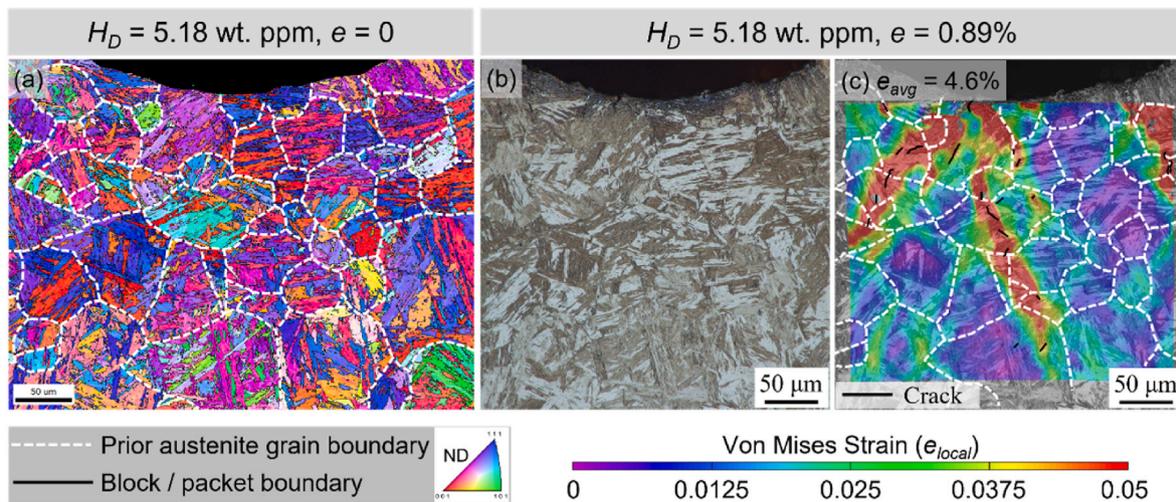
**Fig. 7.** Results of the correlative analysis for the hydrogen-charged specimen with  $H_D = 5.18$  wt ppm at a nominal strain level of 0.89 %. (a) IPF map obtained before deformation, (b) optical microscopy image showing the crack distribution after deformation, (c) strain distribution map by DIC analysis.

The correlative analysis results of the hydrogen-charged specimen with  $H_D = 5.18$  wt ppm are presented in Fig. 7. At a similar nominal strain level, the hydrogen-charged specimen exhibited enhanced strain localization behavior (Fig. 7c) compared to the uncharged specimen (Fig. 6c). In contrast to the uncharged specimen, many small cracks appeared as indicated by the black lines (Fig. 7c). A major portion of the strain localization exhibits elongated band-like morphology, and these strain-localized regions mainly correspond to the bulk of the blocks and the vicinity of PAGBs. We can find that the cracks tend to form within these strain-localized regions, suggesting that crack initiation requires a certain plastic deformation.

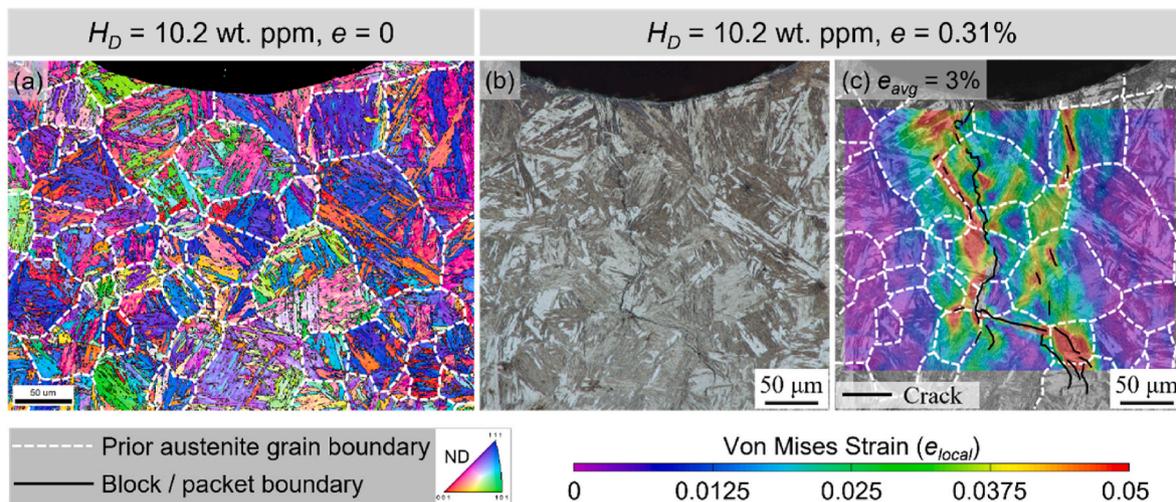
**Fig. 8.** Results of the correlative analysis for the hydrogen-charged specimen with  $H_D = 10.2$  wt ppm at a nominal strain level of 0.31 %. (a) IPF map obtained before deformation, (b) optical microscopy image showing the crack distribution after deformation, (c) strain distribution map by DIC analysis.

Fig. 8 shows (a) the IPF map obtained before deformation, (b) optical microscopy image showing the crack distribution after deformation, and (c) strain distribution map of the hydrogen-charged specimen with  $H_D =$

10.2 wt ppm. In Fig. 8b, it can be observed that one large crack formed at the notch root and propagated to the specimen interior. Additionally, a significant number of small cracks also formed. Local plastic deformation was detected even in the apparent elastic strain regime ( $e = 0.31\%$ ). The clear correlation between the cracking sites and the highly deformed regions can be confirmed. The strain mapping analysis correlated with the EBSD crystallographic mapping also revealed that the strain localization was related to microstructures, similar to those observed in Fig. 6c and 7c. From Figs. 6–8, we found that the crack nucleation and growth were enhanced with increasing  $H_D$ , even though the nominal strain is much smaller.

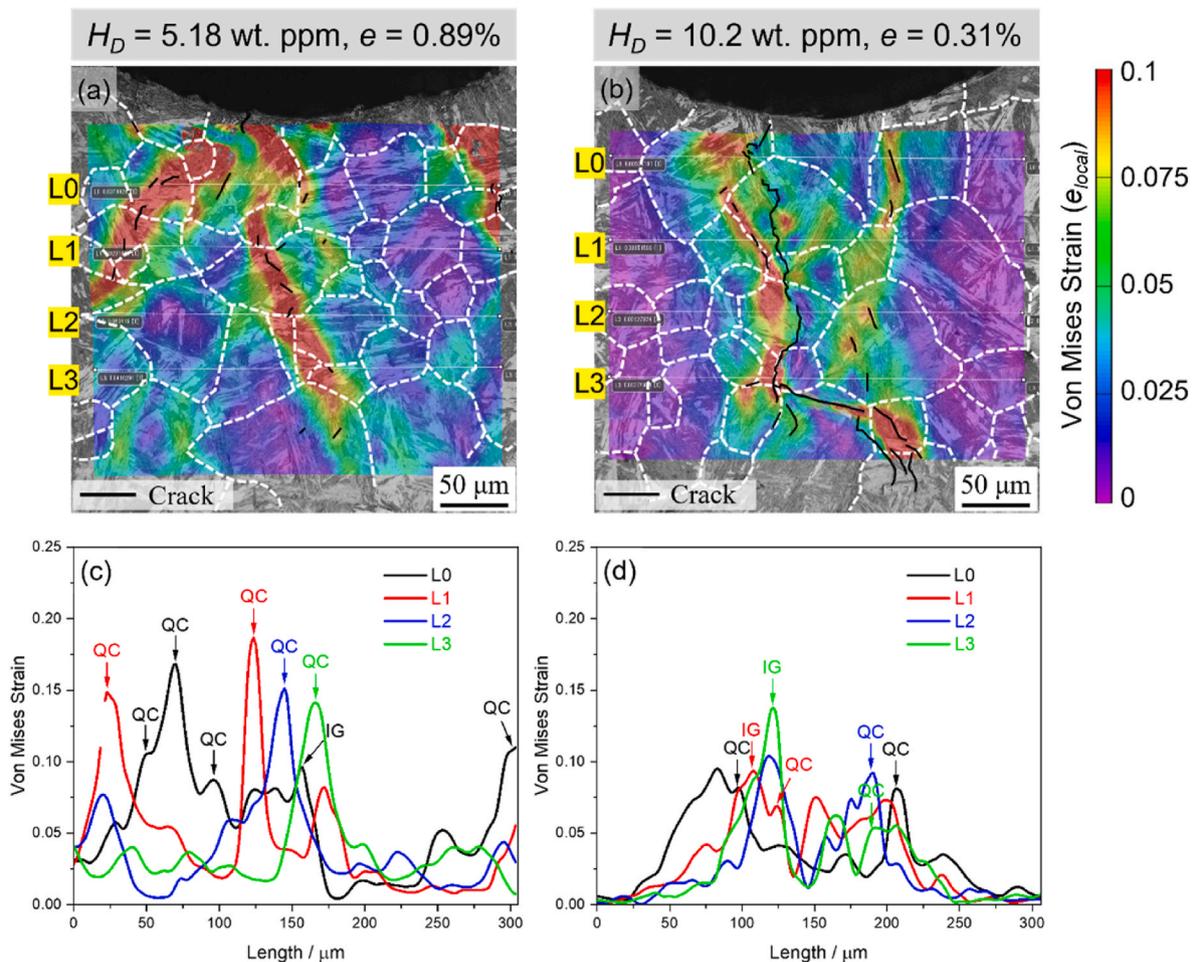
**Fig. 9.** (a) Strain distribution map and (c) corresponding local strain profiles obtained at  $e = 0.89\%$  in the hydrogen-charged specimen with  $H_D = 5.18$  wt ppm; (b) Strain distribution map and (d) corresponding local strain profiles obtained at  $e = 0.31\%$  in the hydrogen-charged specimen with  $H_D = 10.2$  wt ppm.

The relationship between cracking, microstructure, and local plasticity was quantitatively investigated using local strain profiles, as shown in Fig. 9. The inspection lines (L0 ~ L3) in the strain distribution maps (Fig. 9a and b) represent the locations where the local strain profiles were measured. As shown in Fig. 9c and d, the strain peaks are likely to correspond to the cracked regions or strain-localized regions. The fracture modes (QC for quasi-cleavage and IG for intergranular) of the cracks encountered by the inspection lines are indicated in the corresponding local strain profiles. The results show that the local strain

around the quasi-cleavage crack in the hydrogen-charged specimen with  $H_D = 10.2$  wt ppm tends to be lower than that in the hydrogen-charged specimen with  $H_D = 5.18$  wt ppm. The lower local strain implies that increasing  $H_D$  decreases the local strain level required for quasi-cleavage cracking. It is noteworthy that the strain localization also appears around the intergranular cracking, suggesting that the strain localization is also involved in the sequence of intergranular cracking.

hydrogen enhanced strain localization during deformation and that significant local plastic deformation accompanied the quasi-cleavage fracture process. The quantitative analysis shown in Fig. 9 indicated that increasing hydrogen content decreased the local strain level required for quasi-cleavage cracking. Shibata et al. [34] investigated the local conditions for hydrogen-related fracture in a low-carbon martensitic steel and found that the local values of the maximum principal stress, plastic strain, and hydrogen content at the initiation sites of the quasi-cleavage cracks were different depending on the stress concentration factor. Their finite element simulation results are consistent with our experimental results, namely, a higher local hydrogen content results in a lower local strain level for quasi-cleavage cracking. Matsumoto et al. [35] reported that hydrogen reduced the vacancy formation energy and increased the activation energy for vacancy diffusion based on first-principles calculations. They suggested that supersaturated vacancies generated by screw dislocations jog-dragging accumulated in the vicinity of the slip planes and facilitated hydrogen-related cracking during plastic deformation in hydrogen environments. Okada et al. [36] investigated the effect of hydrogen on the evolution of deformation microstructure in a ferritic steel and found that hydrogen increased the relative velocity of screw dislocations to edge dislocations, resulting in
